## Case history 3 using on-line snapshot Ultrasonic method

Partial Discharge Equipment use : **UE 9000**      Mode of measurement : snapshot

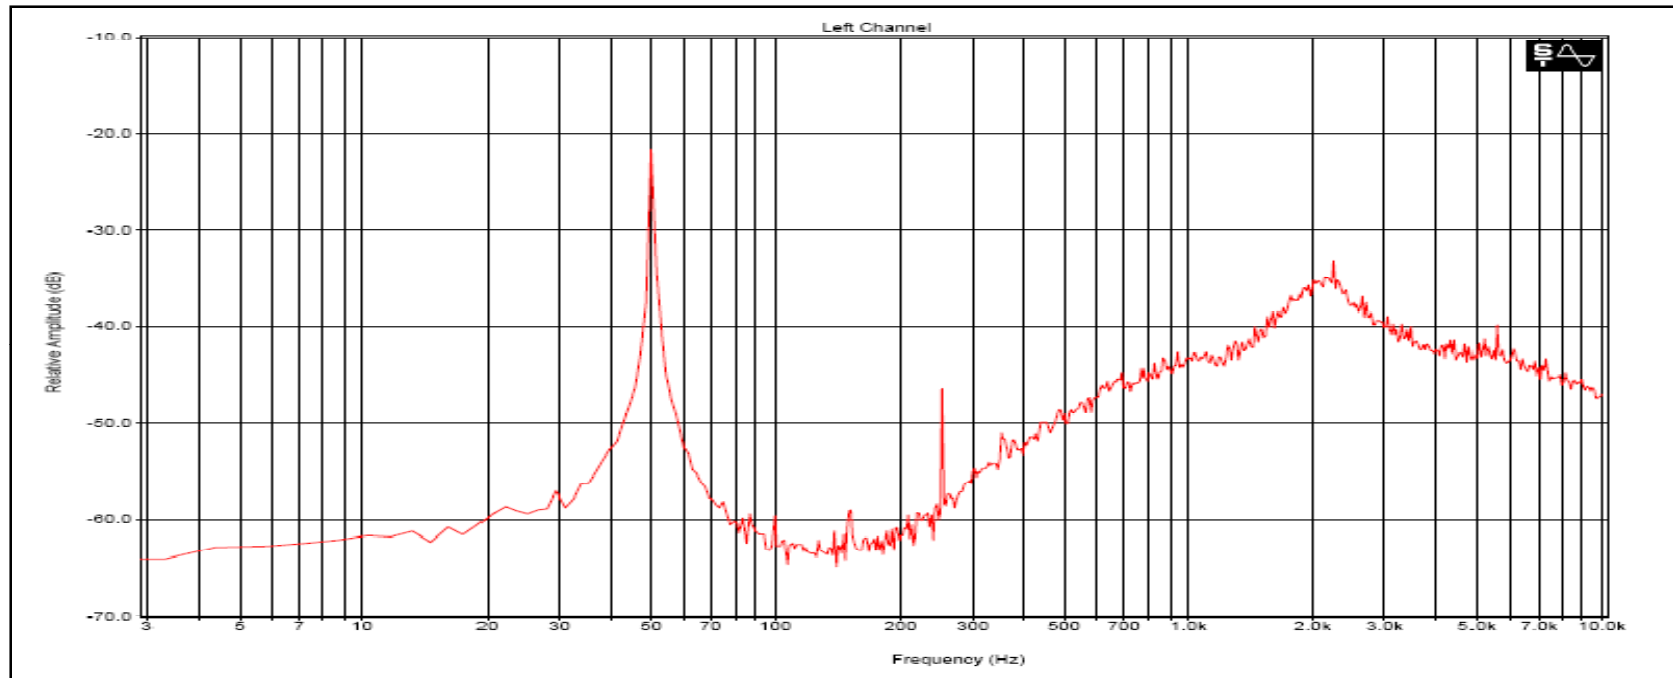
- 1) Date of measurement : 15<sup>th</sup> November 2003
- 2) Type of equipment : 22kV connection of 8MVA, 22/6.6kV Dry type Transformer
- 3) Analysis :  
Loud and audible discharge was heard at the 22kV side of the dry type transformer.  
Ultrasonic scan showed large 50Hz spike and located the source of the discharge at a defective insulating support.
