Case History – 11 : Using Online Snapshot Ultrasonic Method

Equipment Under measurement : **22kV AIS Siemens Switchgear**

Date of Measurement : **08th August 2014**

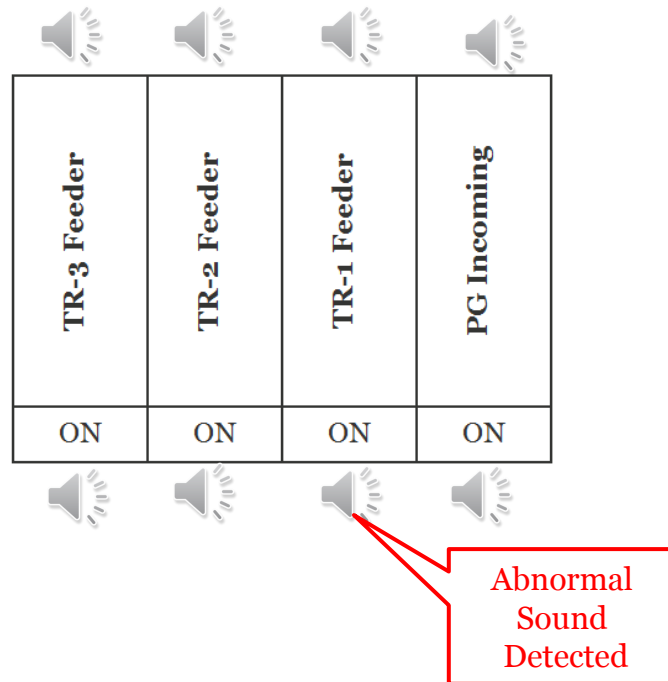
Observation: **Surface discharge was found at the Busbar and Circuit breaker contact with green corrosion spotted.**

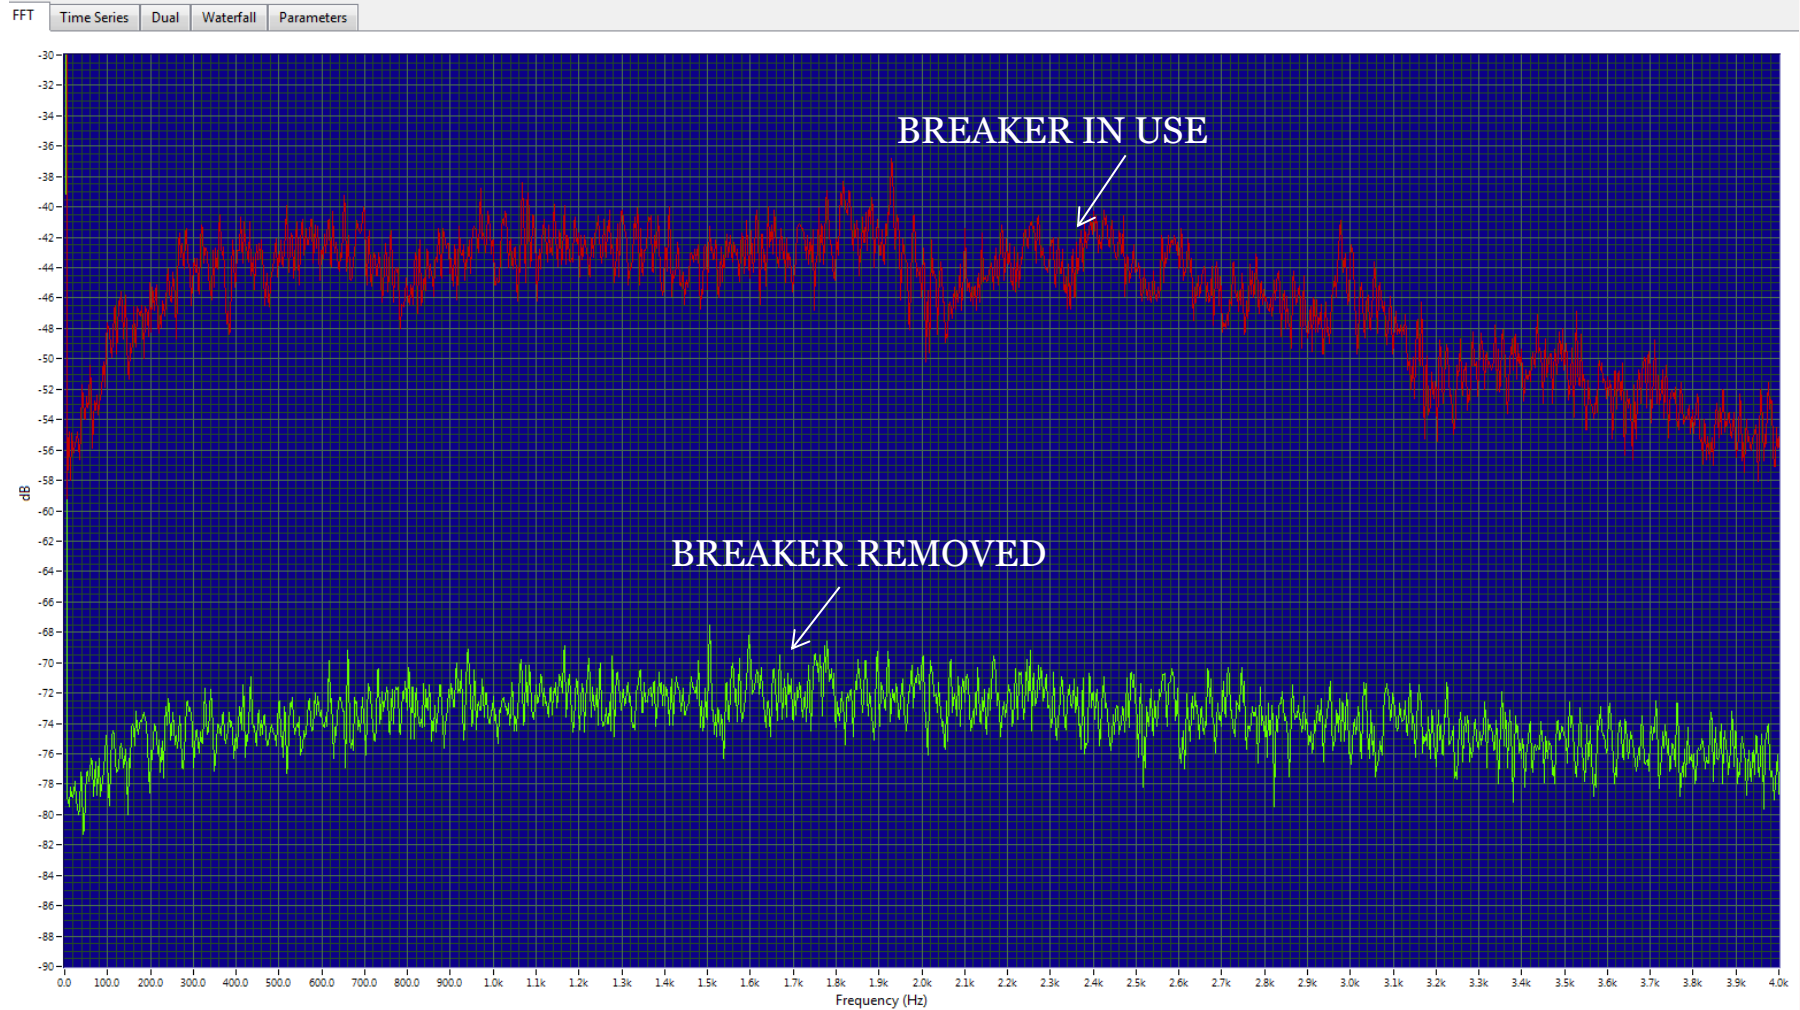
TR1 FEEDER PANEL (FRONT SIDE)

ABNORMAL ULTRASOUND DETECTION

- Frequency Domain

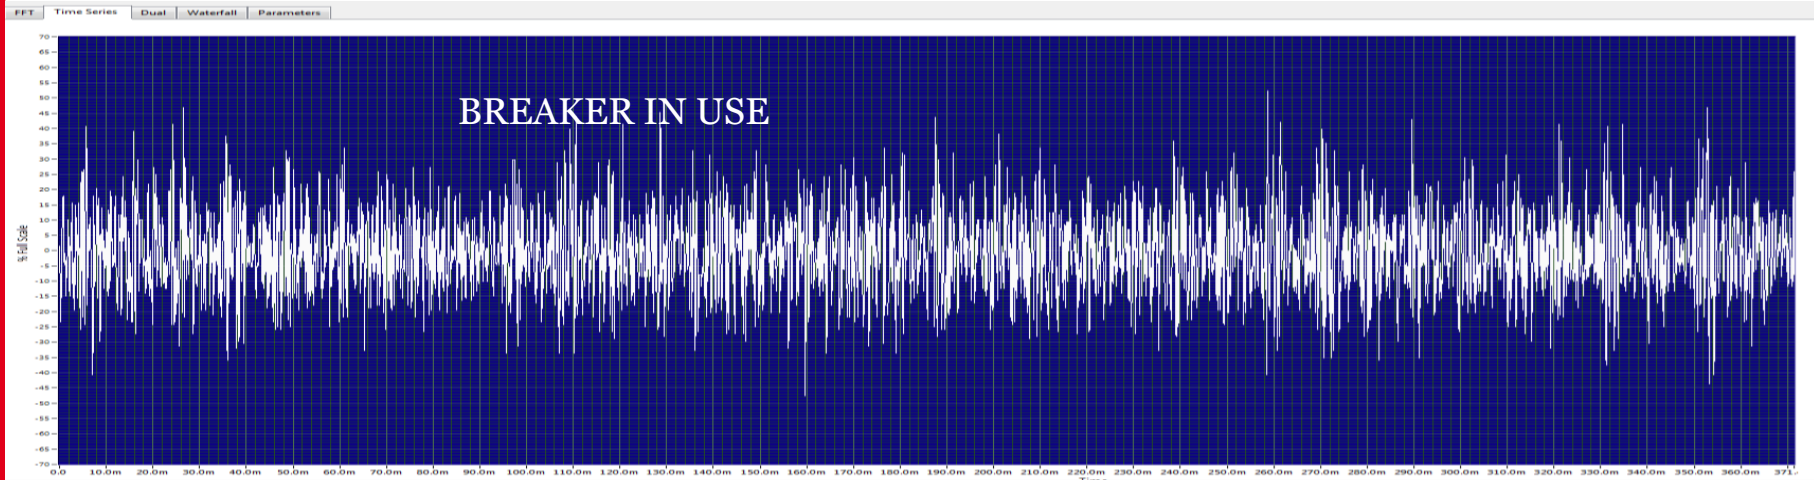
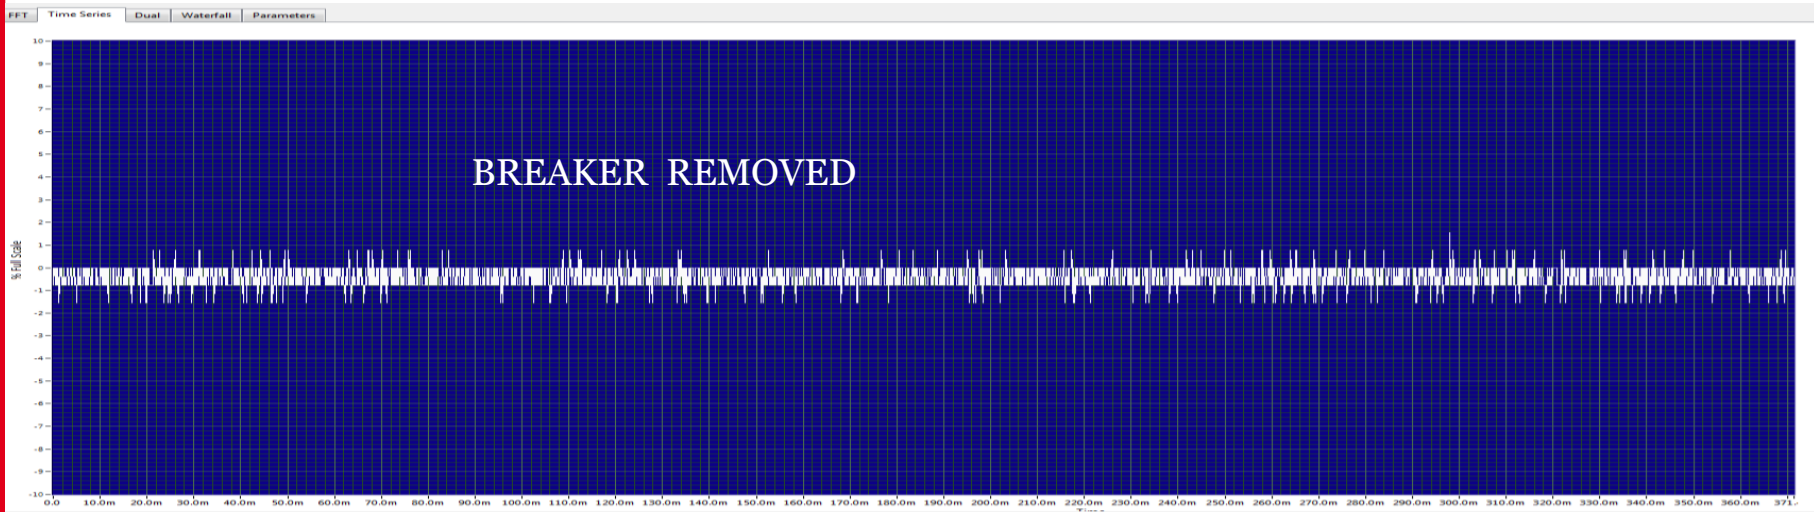
TR1 FEEDER PANEL (FRONT SIDE)

- Time Domain

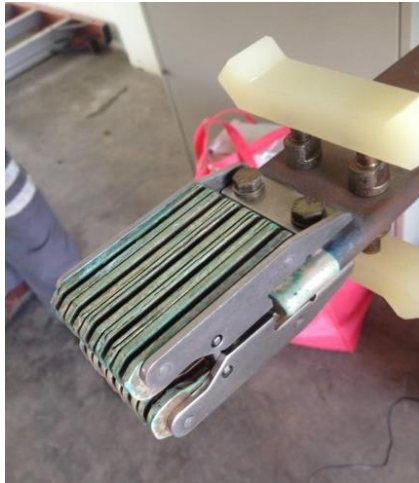
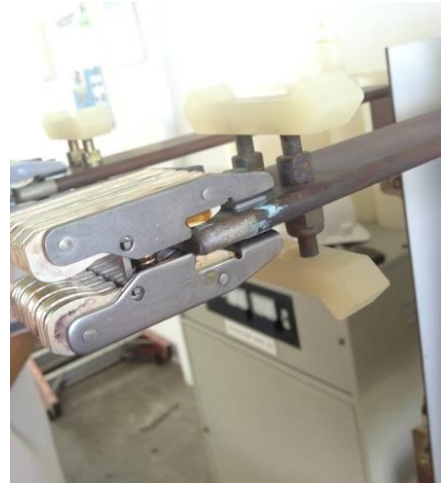
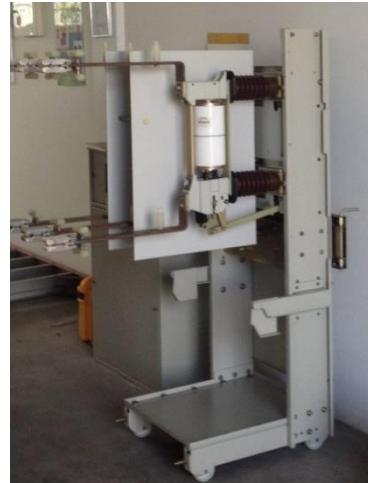
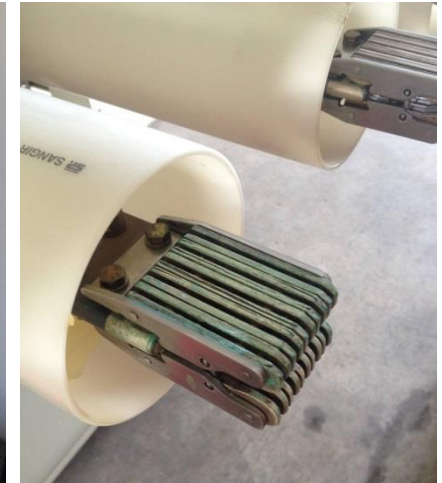
Green Color at 22kV Circuit Breaker Contact, which indicate insufficient contact pressure
