## **Case History - 14: Using Online Ultrasonic Method**

Equipment Under Measurement: **22kV AIS, FUJI**

Date of Measurement: **15<sup>th</sup> July 2015**

**ONLINE PD MEASUREMENT USING SNAPSHOT ULTRASONIC SENSORS  
FOR 22kV FUJI AIS @ HT SWITCHROOM**

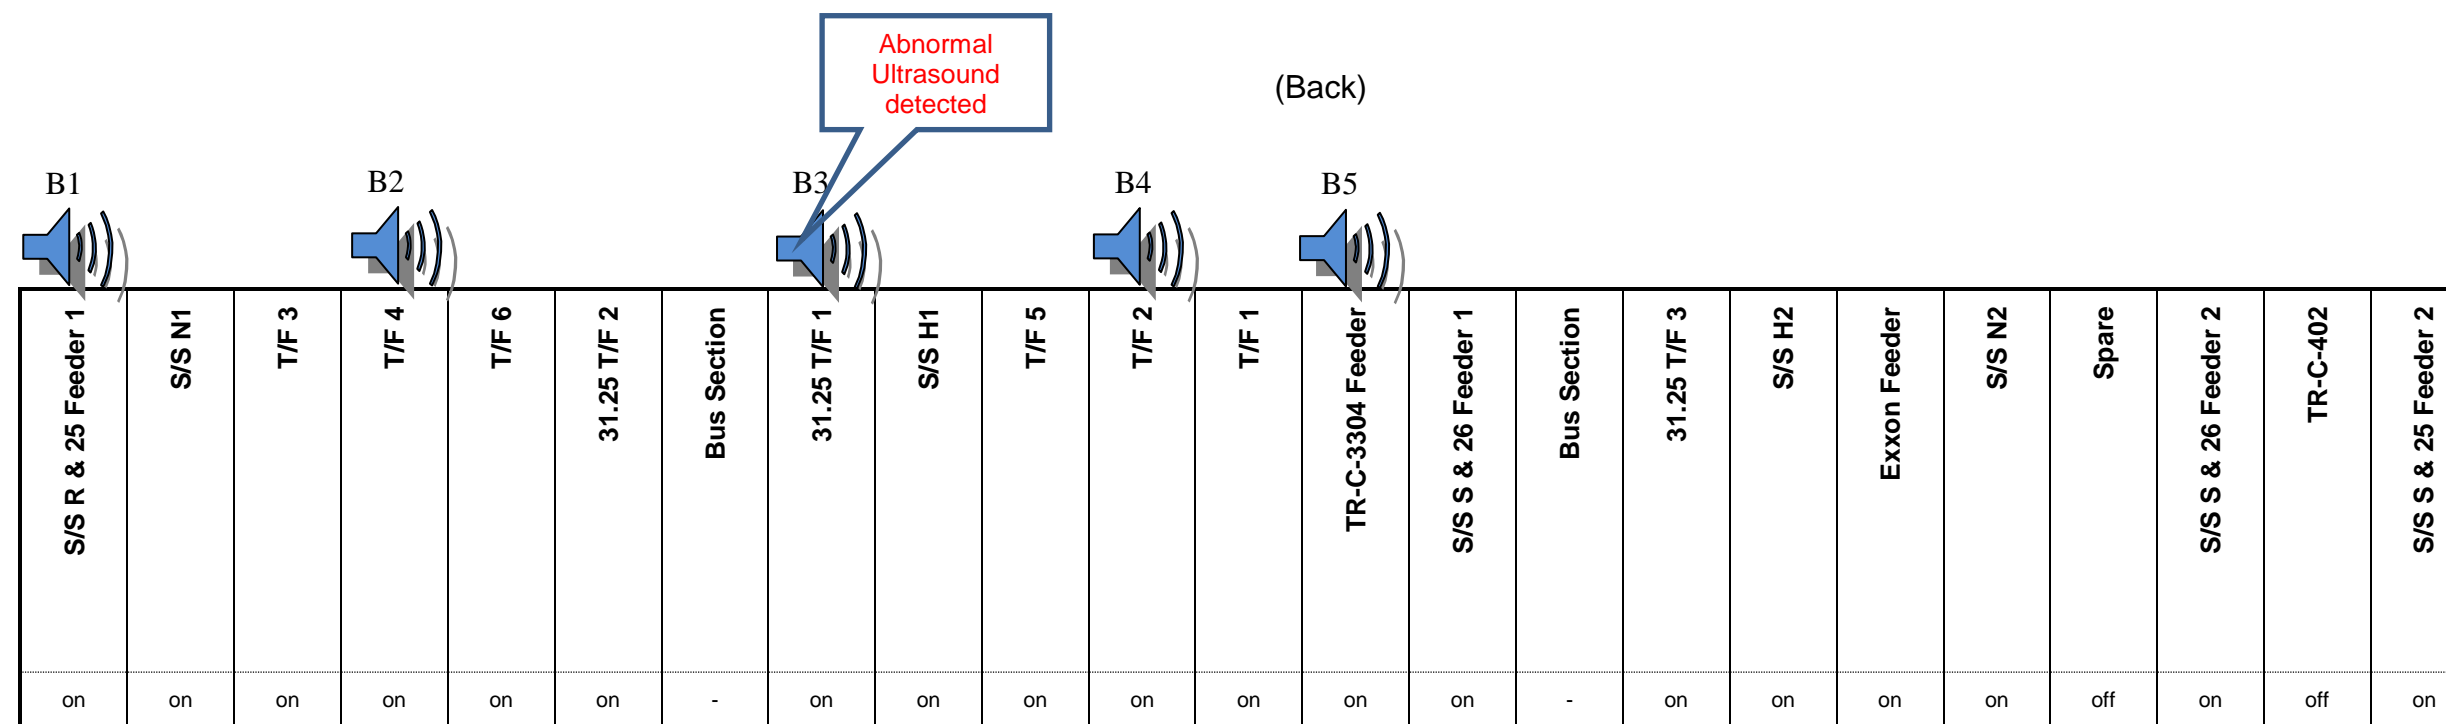
(Front)

ULTRASONIC ACCESS POINT :	
Back side of Switchgear	<input type="checkbox"/> Louver <input type="checkbox"/> Screw Opening <input checked="" type="checkbox"/> Gap in between Panels <input type="checkbox"/> Others
Front side of Switchgear	<input type="checkbox"/> Louver <input type="checkbox"/> Screw Opening <input checked="" type="checkbox"/> Gap in between Panels <input type="checkbox"/> Others
ON-SITE AUDIO MEASUREMENT DETAILS :	
Background Ultrasonic Scan	<input checked="" type="checkbox"/> Yes <input type="checkbox"/> No
Abnormal Source Detected (Background)	<input type="checkbox"/> Yes <input checked="" type="checkbox"/> No   If Yes, _____
Component Ultrasonic Scan	<input checked="" type="checkbox"/> Cable termination <input type="checkbox"/> Circuit Breaker <input type="checkbox"/> VT <input type="checkbox"/> Bus Bar <input type="checkbox"/> Others
Abnormal Source Detected (Component)	<input checked="" type="checkbox"/> Yes <input type="checkbox"/> No   If Yes, <b>At the back panel of Circuit "31.25 TF-1"</b>

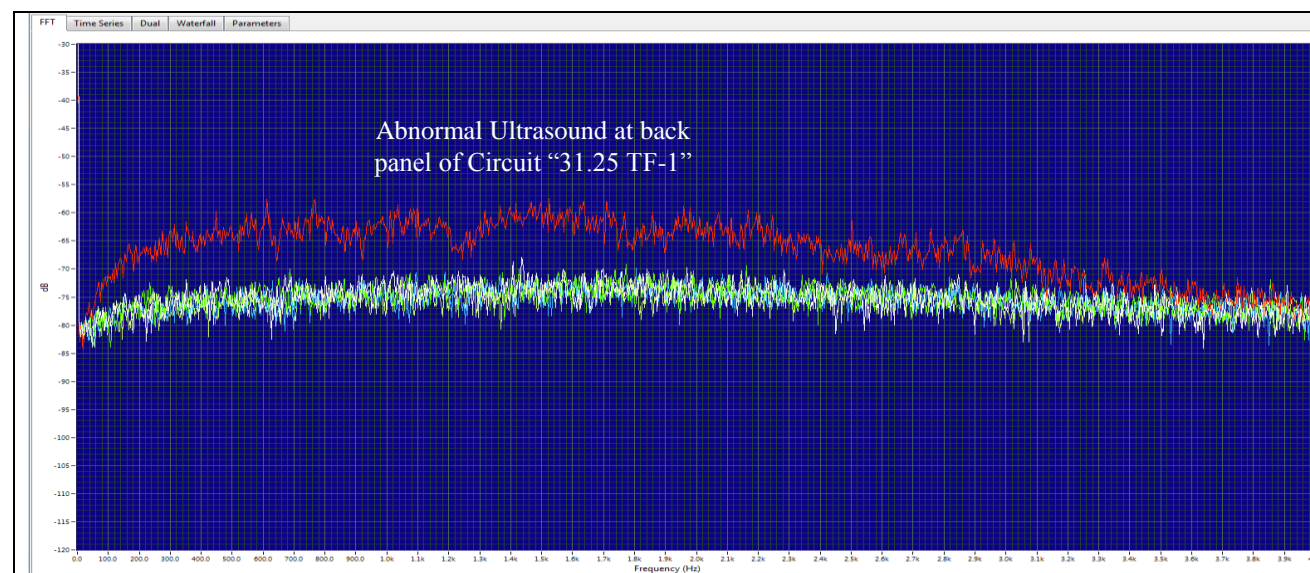
• **Frequency Domain Analysis (Before SDM \_ Measured on 15<sup>th</sup> July 2015)**

• Audio Analysis => **Abnormal ultrasound was detected.**

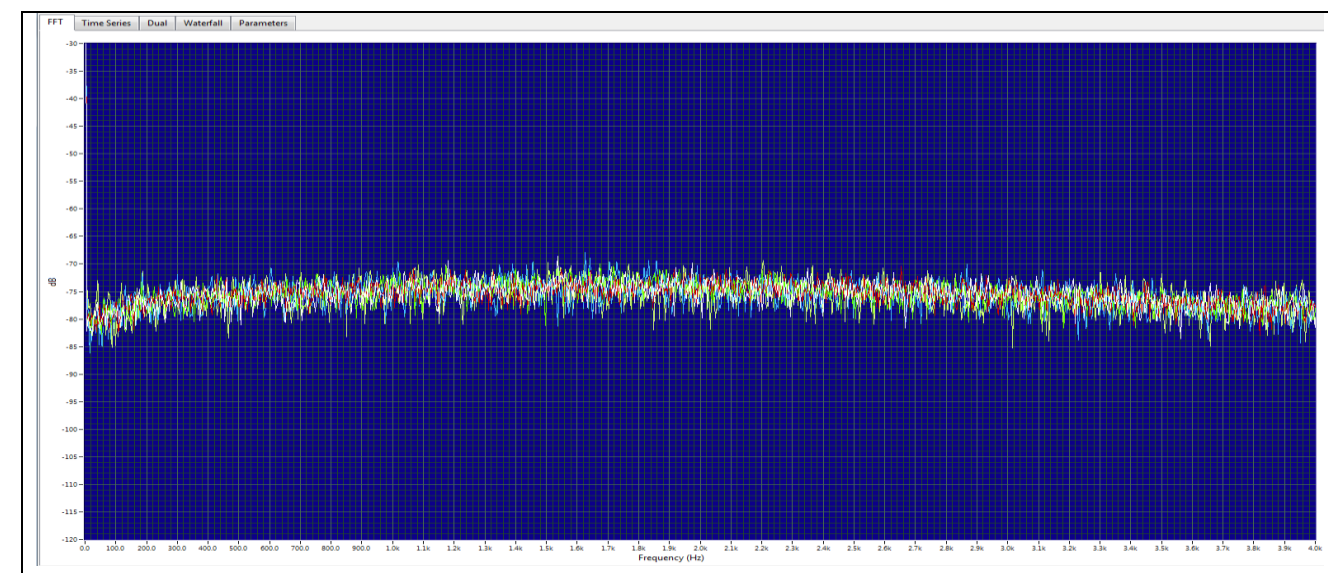
• **Frequency Domain Analysis (After SDM \_ Measured on 20<sup>th</sup> July 2015)**

• Audio Analysis => **No Abnormal ultrasound was detected**

*\*SDM was done on 16<sup>th</sup> July 2015.*

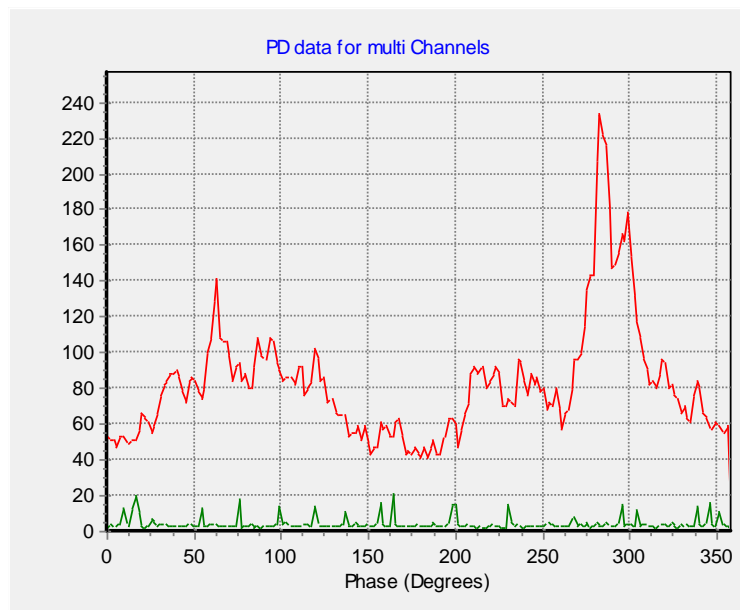
- Airborne Ultrasonic in Phase Resoled Mode Measurement (Before SDM \_ Measured on 15<sup>th</sup> July 2015)**

PASS	<input type="checkbox"/>
FAIL	<input checked="" type="checkbox"/>

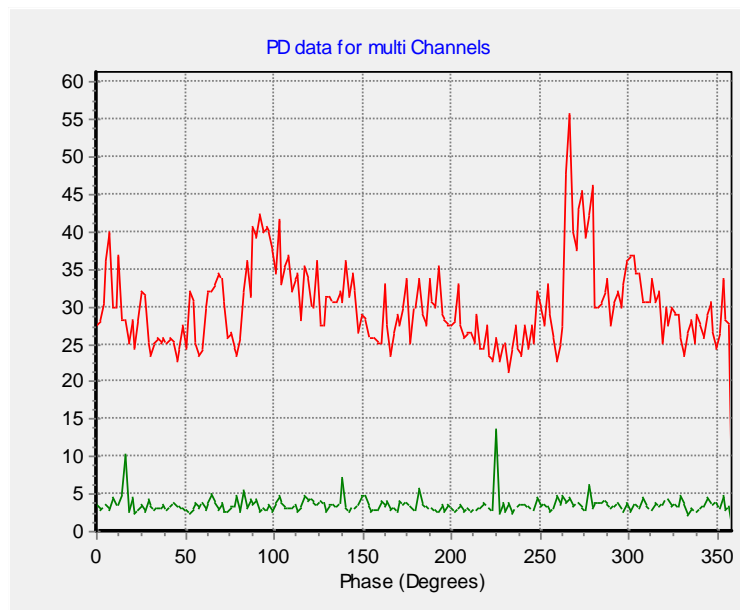
- Airborne Ultrasonic in Phase Resoled Mode Measurement (After SDM \_ Measured on 20<sup>th</sup> July 2015)**

PASS	<input checked="" type="checkbox"/>
FAIL	<input type="checkbox"/>

\*SDM was done on 16<sup>th</sup> July 2015.

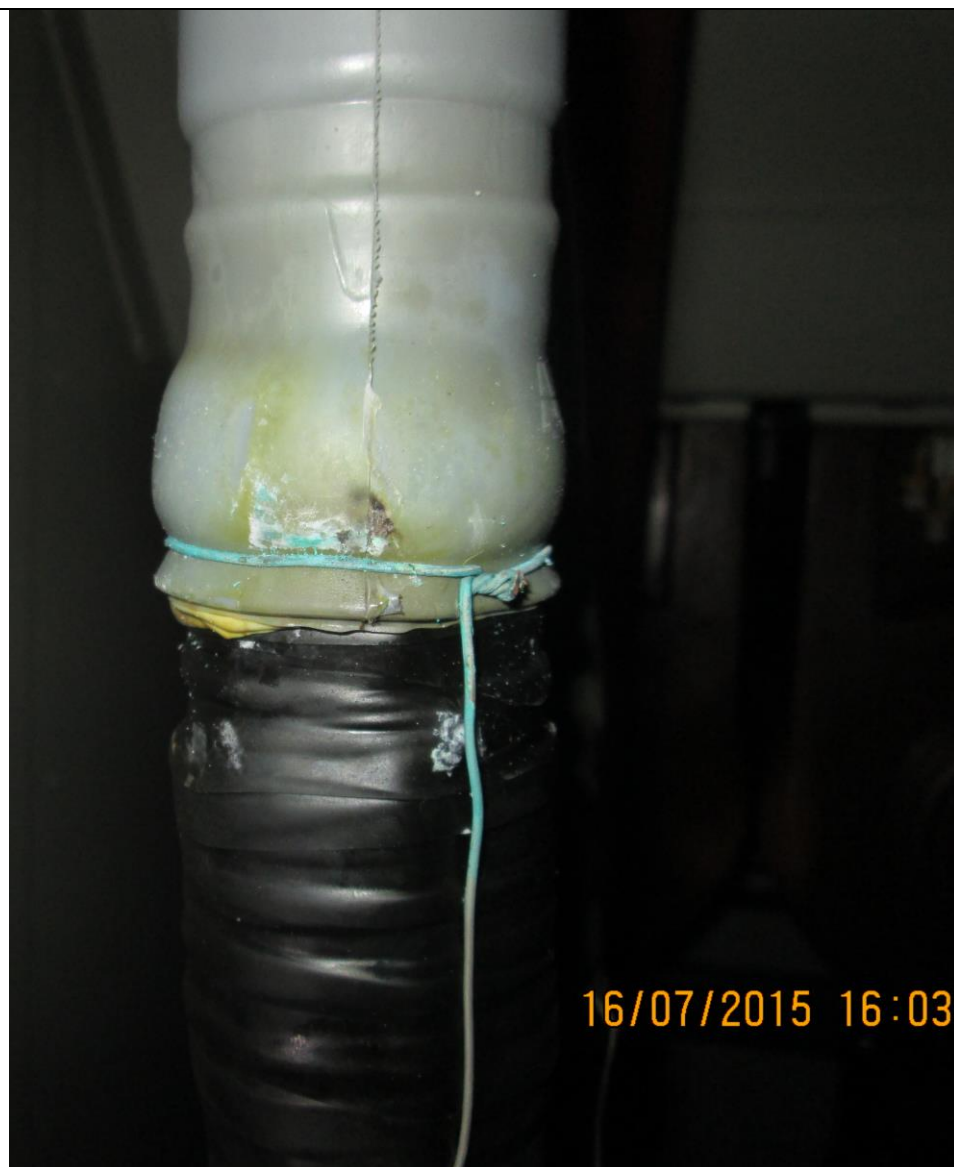
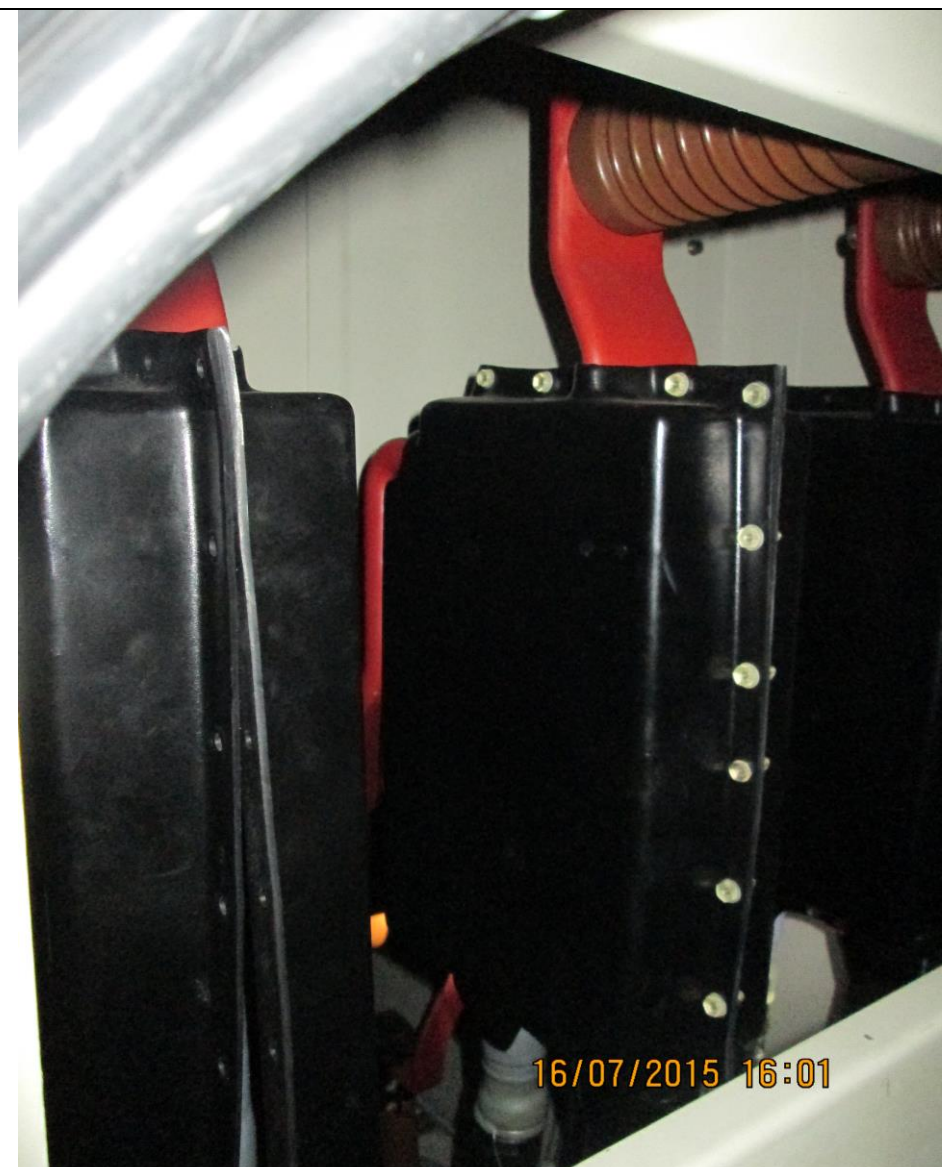
**OBSERVATION DURING SHUTDOWN MAINTENANCE FOR 22kV AIS @ HT SWITCHROOM**

Observation: **Visible electrical treeing which originates from the point of touching with cable and the black insulation cover.**

**Visible Electrical treeing which originates from the point of touching with cable and the black insulation cover.**

*\*SDM was done on 16<sup>th</sup> July 2015.*
