Case History - 17: Using Online Ultrasonic Method

Equipment under Measurement: **11kV AIS, Merlin Gerin**

Date of Measurement: **25th September 2015**

Observation: **Bad Signs of Partial Discharge in 11kV Incomer 1 Yellow Phase Surge Arrester.**

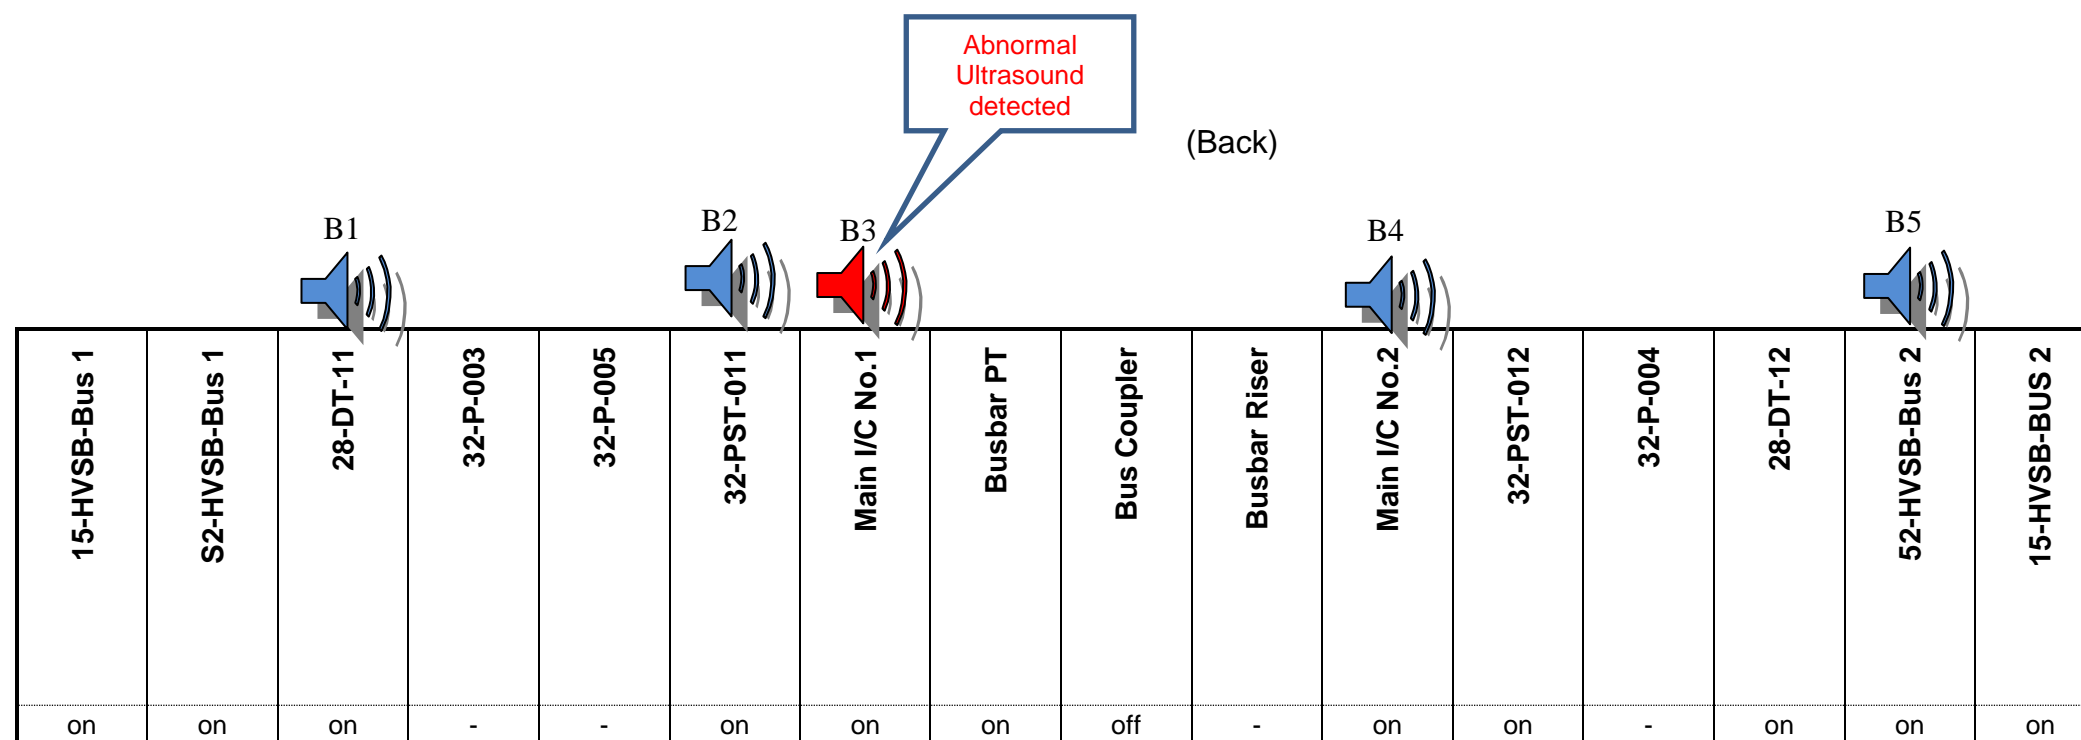
(Front)

LEGEND :	
	Ultrasonud at the back of Switchgear

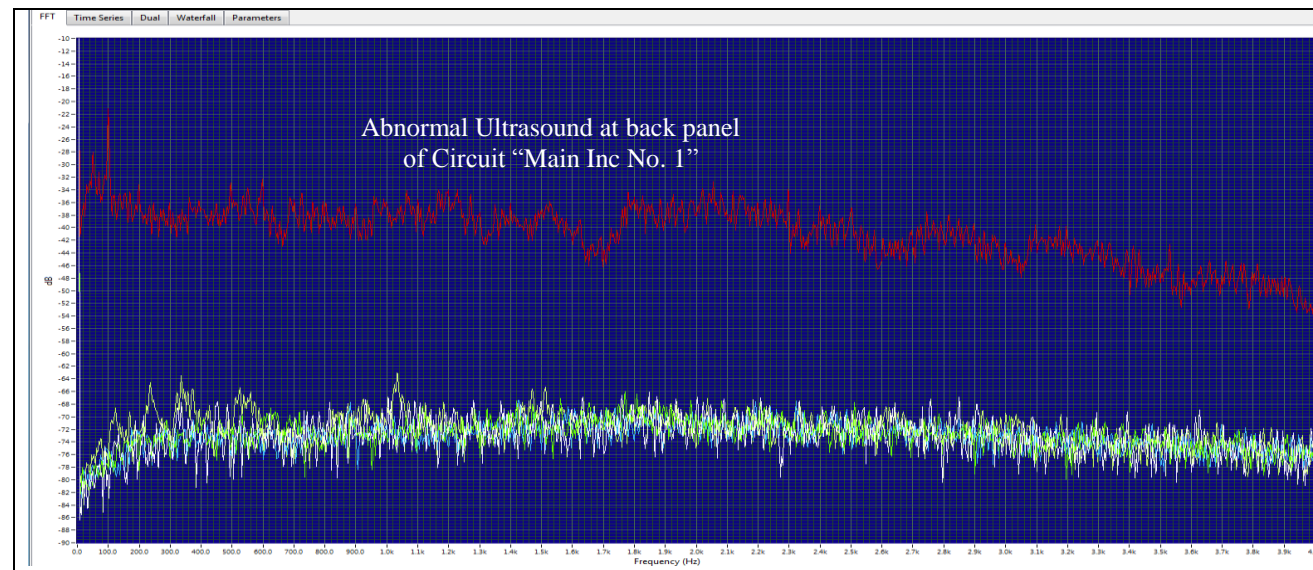
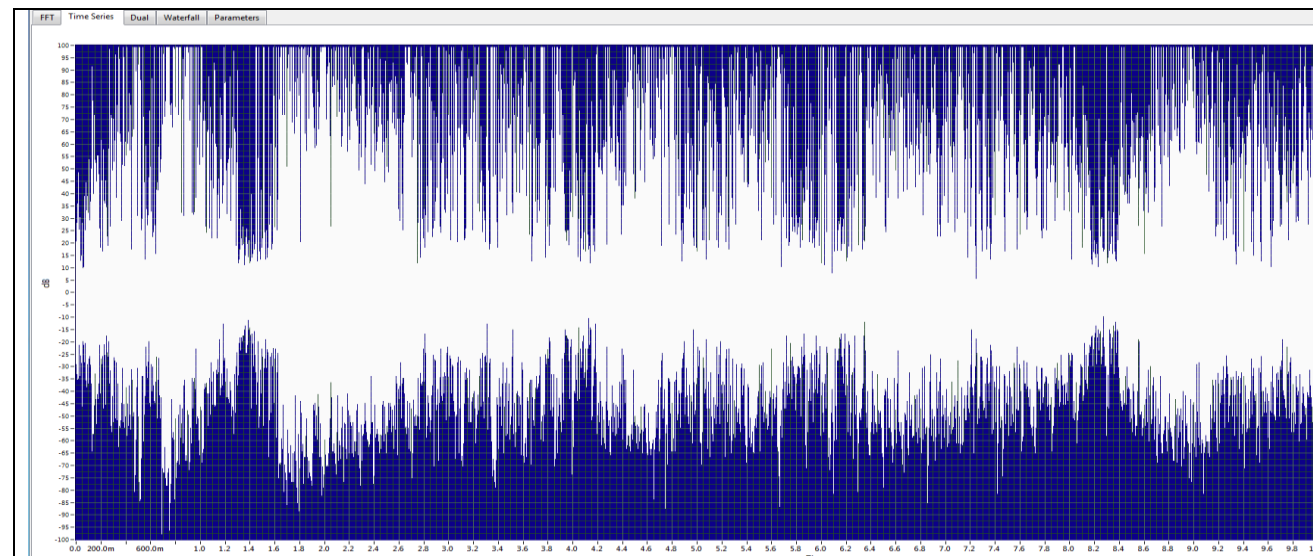
Before removing the Surge Arrester _ Measured on 25 Sept 2015)

• **Frequency Domain Analysis**

• **Time Domain Analysis (Back Panel of Circuit "Main Inc. No.1")**

• Audio Analysis => **High level abnormal ultrasound was detected at the back panel of Circuit "Main Inc. No.1"**

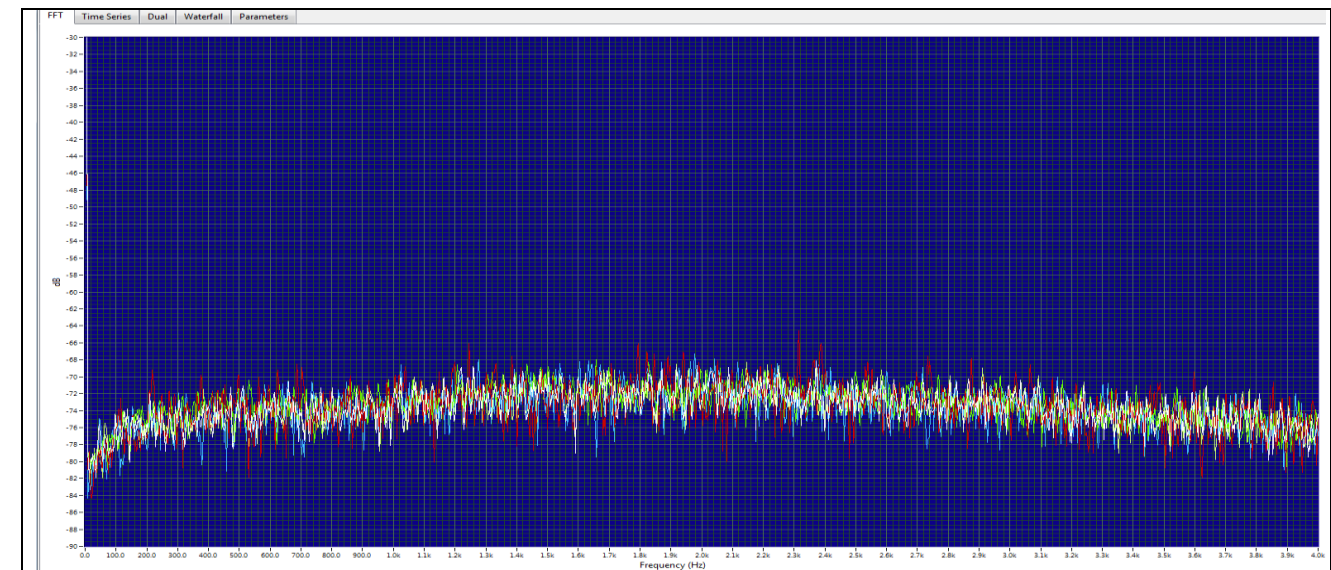
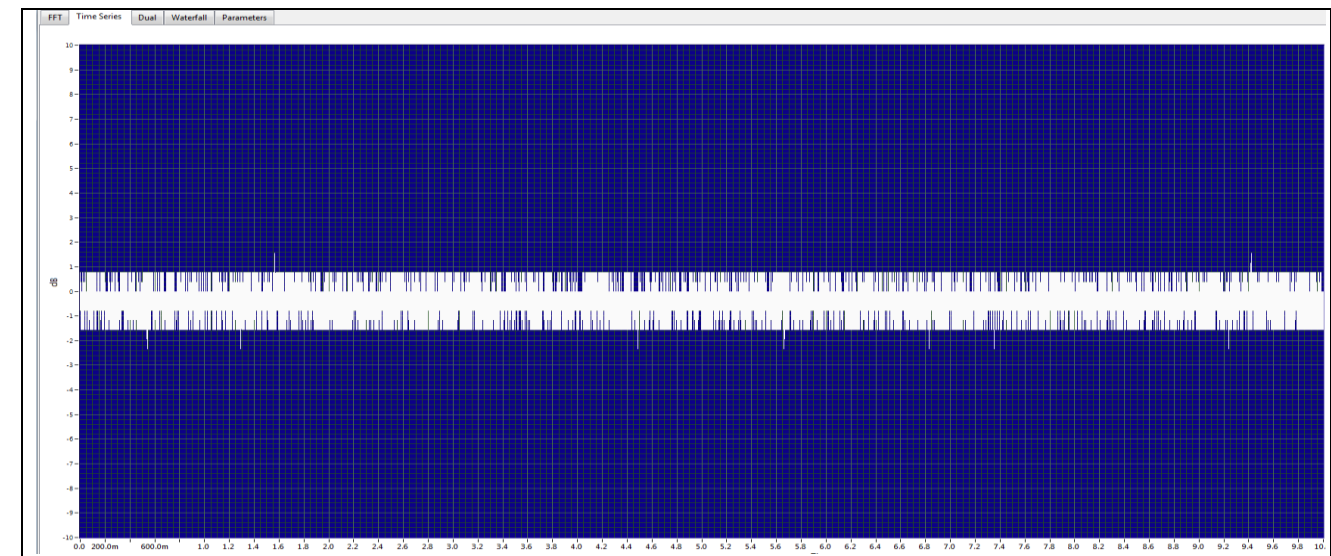
After removing the Surge Arrester _ Measured on 26 Sept 2015

• **Frequency Domain Analysis**

• **Time Domain Analysis (Back Panel of Circuit "Main Inc. No.1")**

• Audio Analysis => **No Abnormal ultrasound was detected.**

* Removing the surge arrester was done on 26th September 2015.

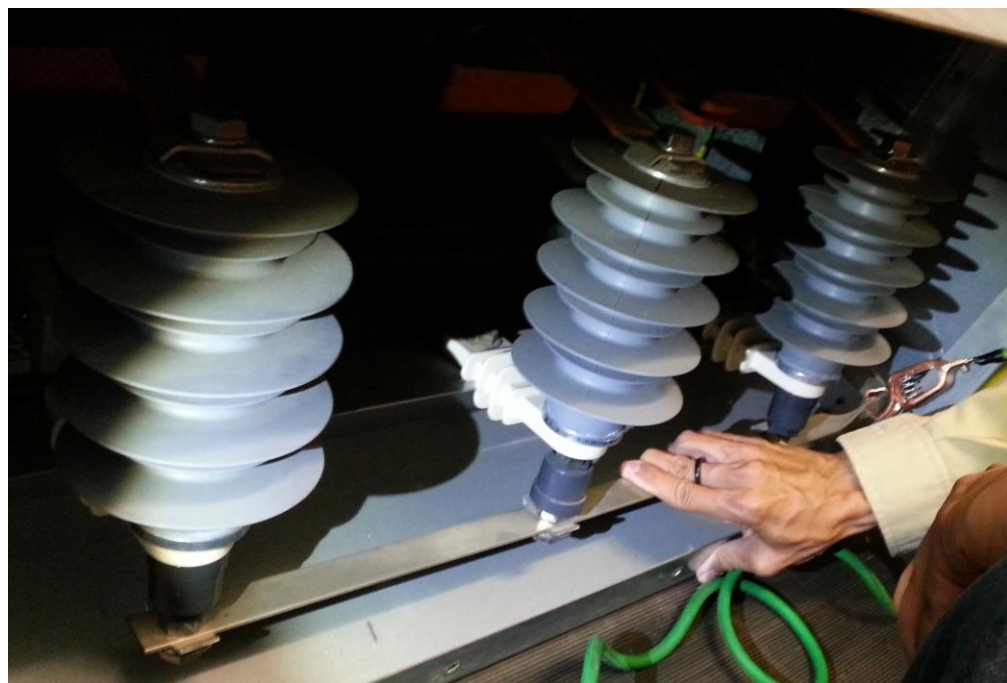
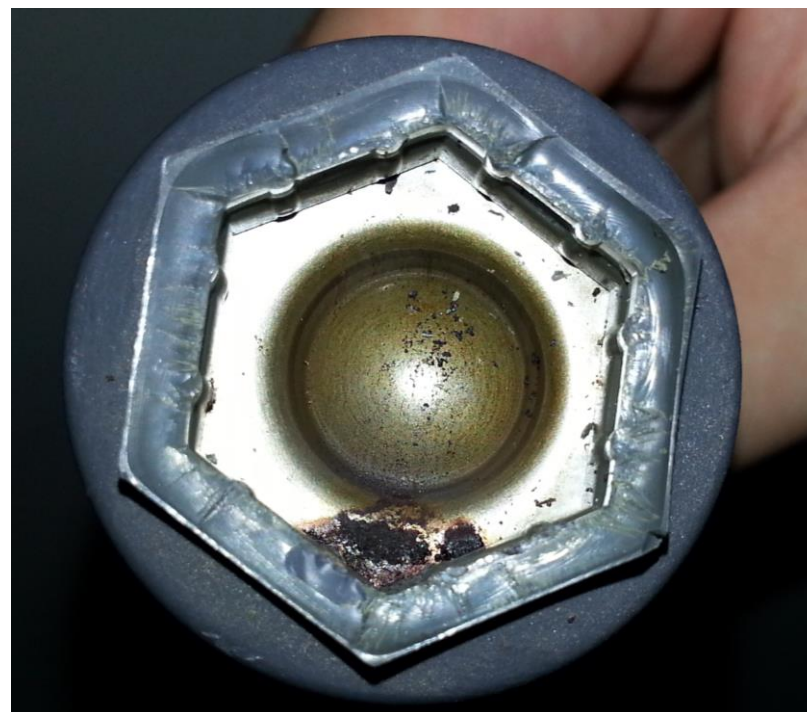
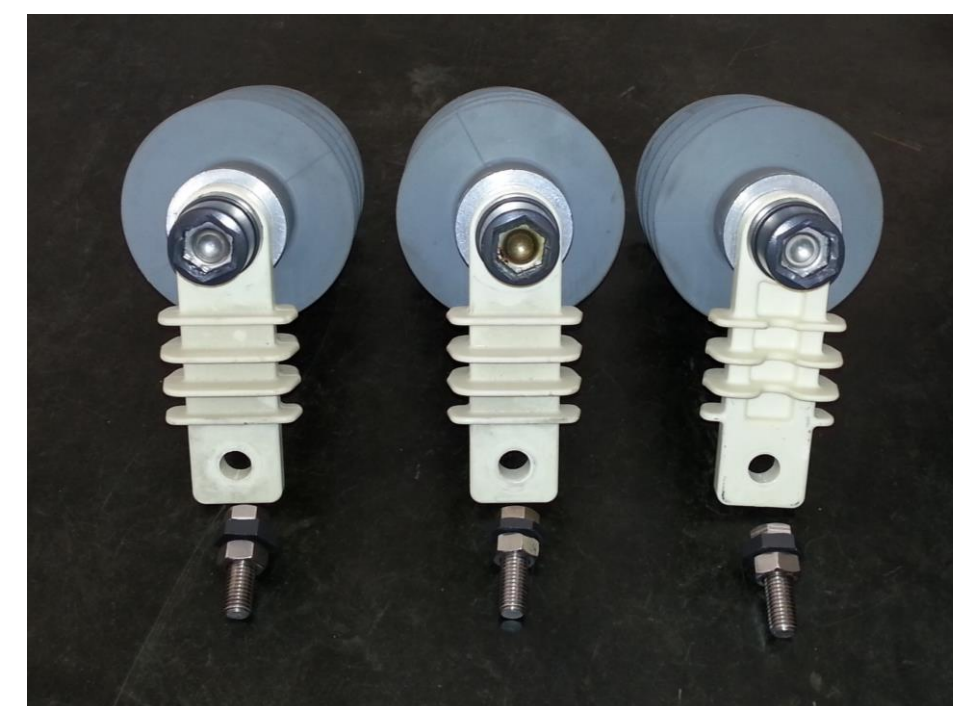
OBSERVATION DURING SHUTDOWN MAINTENANCE

Bad partial discharge signs on 11kV incomer 1 yellow phase surge arrester.

** Removing the surge arrester was done on 26th September 2015.*
