Case History - 20: Using Online Ultrasonic Method

Equipment under Measurement: **6.6kV AIS, Toshiba**

Date of Measurement: **04th September 2015**

ONLINE PD MEASUREMENT USING SNAPSHOT ULTRASONIC READINGS FOR 6.6kV AIS @ 22kV/6.6kV SWITCH ROOM

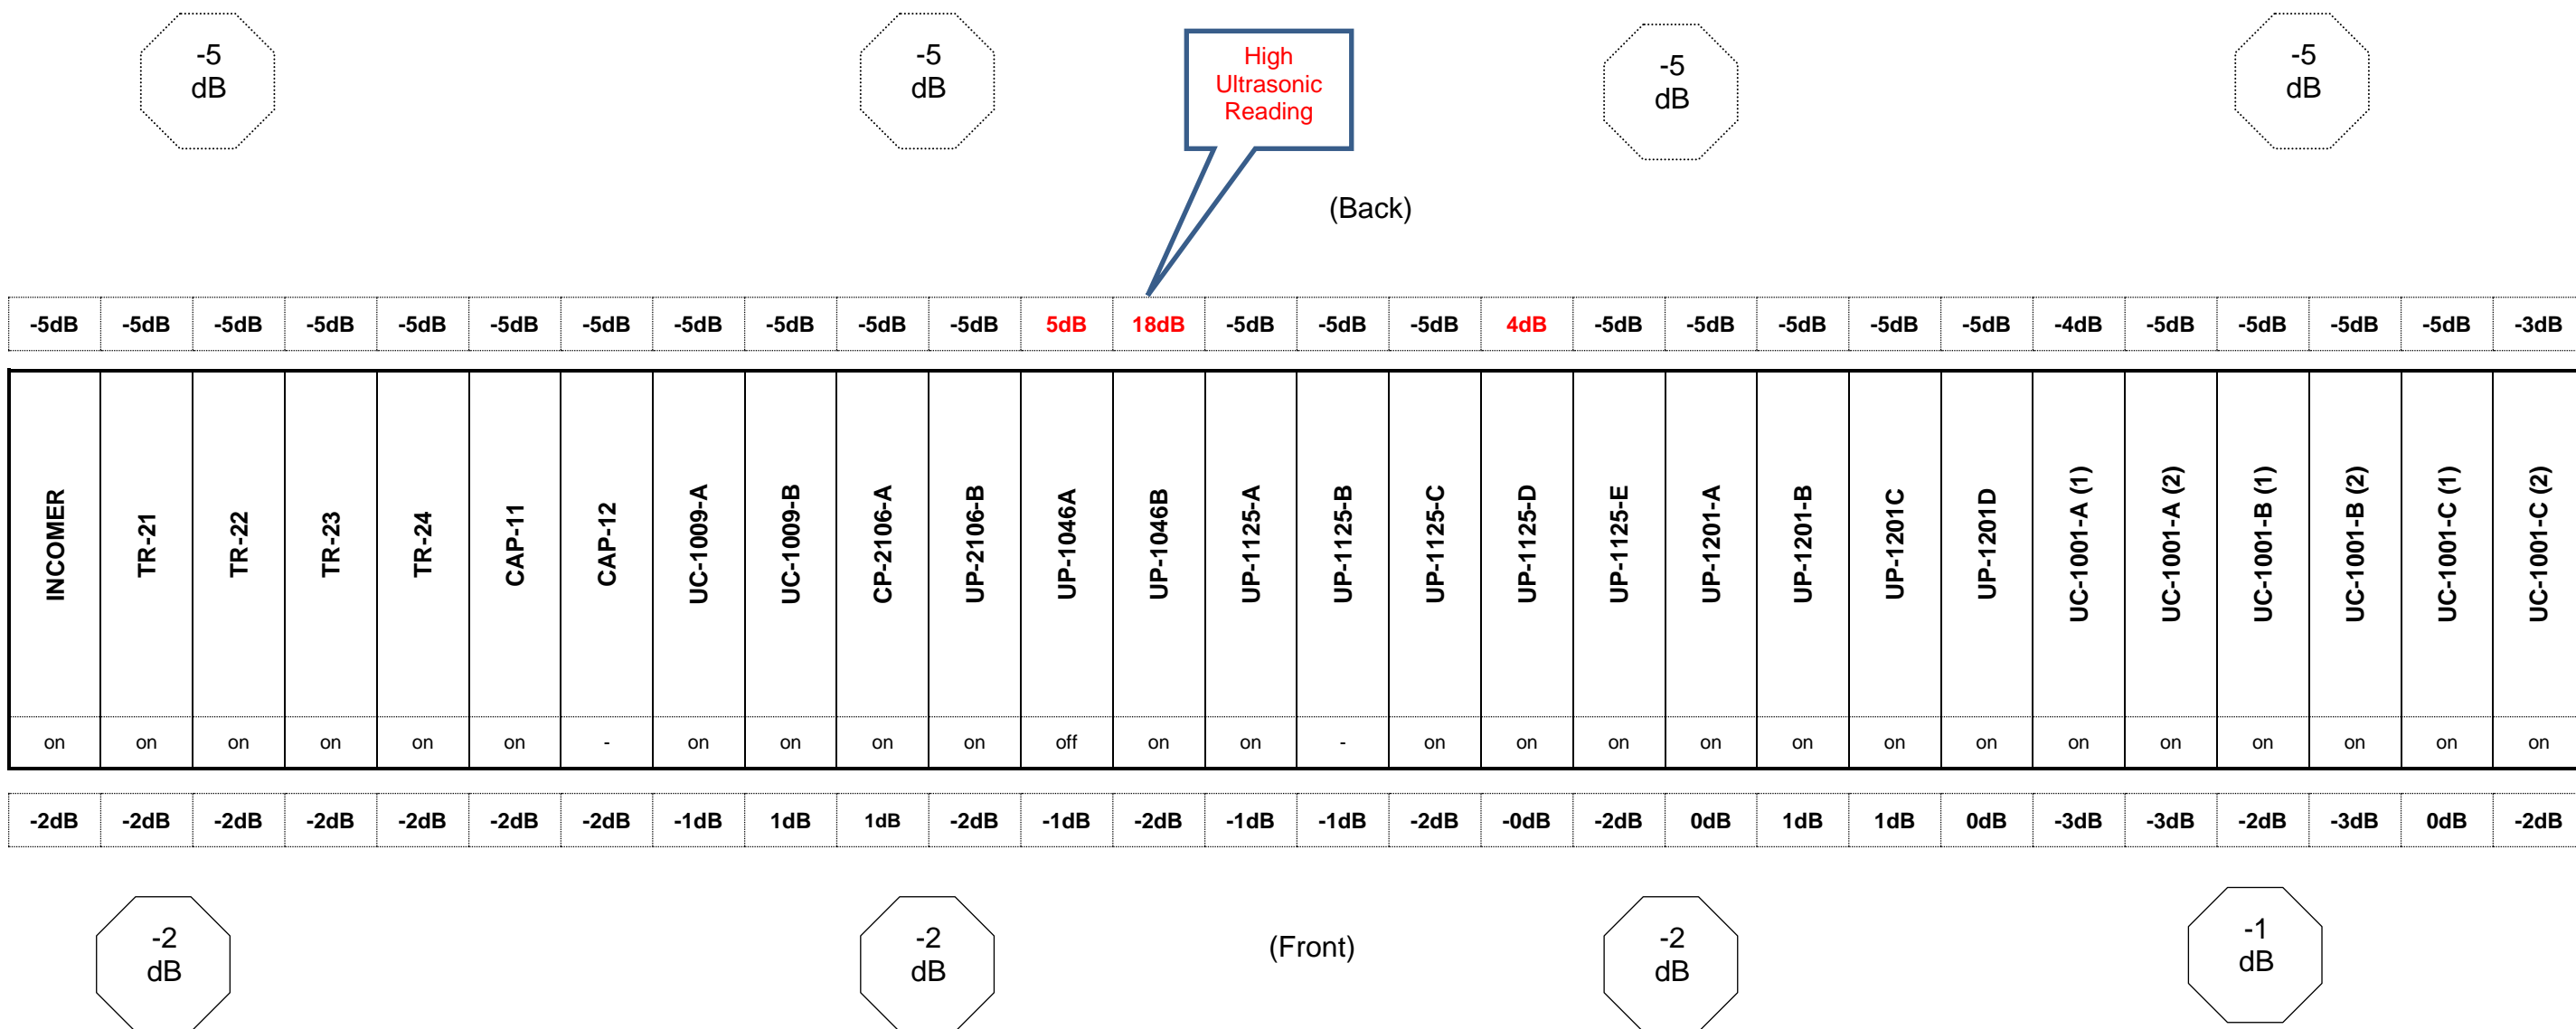
Conclusion : PD detected at the back panel of circuit "UP-1046B" by airborne Ultrasonic sensor

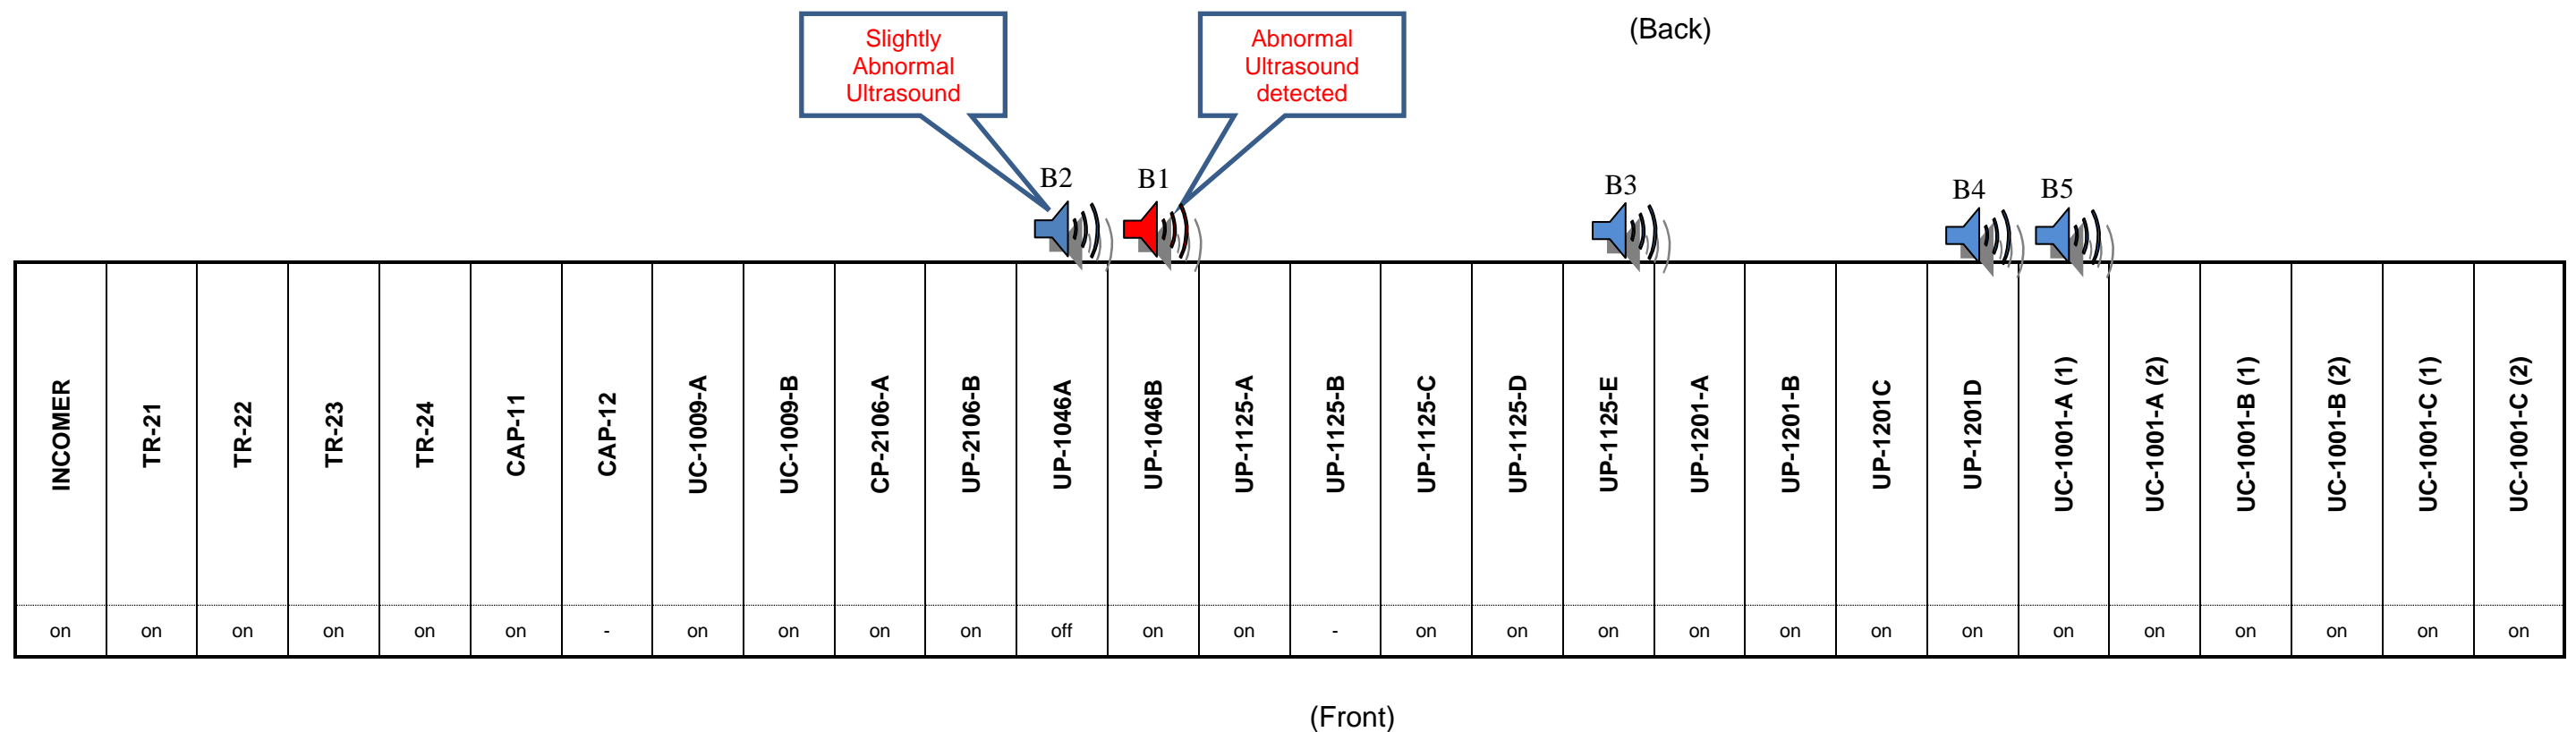
ULTRASONIC ACCESS POINT :	
Back side of Switchgear	<input type="checkbox"/> Louver <input type="checkbox"/> Screw Opening <input checked="" type="checkbox"/> Gap in between Panels <input type="checkbox"/> Others
Front side of Switchgear	<input type="checkbox"/> Louver <input type="checkbox"/> Screw Opening <input checked="" type="checkbox"/> Gap in between Panels <input type="checkbox"/> Others
ON-SITE AUDIO MEASUREMENT DETAILS :	
Background Ultrasonic Scan	<input checked="" type="checkbox"/> Yes <input type="checkbox"/> No
Abnormal Source Detected (Background)	<input type="checkbox"/> Yes <input checked="" type="checkbox"/> No If Yes, _____
Component Ultrasonic Scan	<input checked="" type="checkbox"/> Cable termination <input type="checkbox"/> Circuit Breaker <input type="checkbox"/> VT <input type="checkbox"/> Bus Bar <input checked="" type="checkbox"/> Others
Abnormal Source Detected (Component)	<input checked="" type="checkbox"/> Yes <input type="checkbox"/> No If Yes, At the back panel of Circuit "UP-1046B"

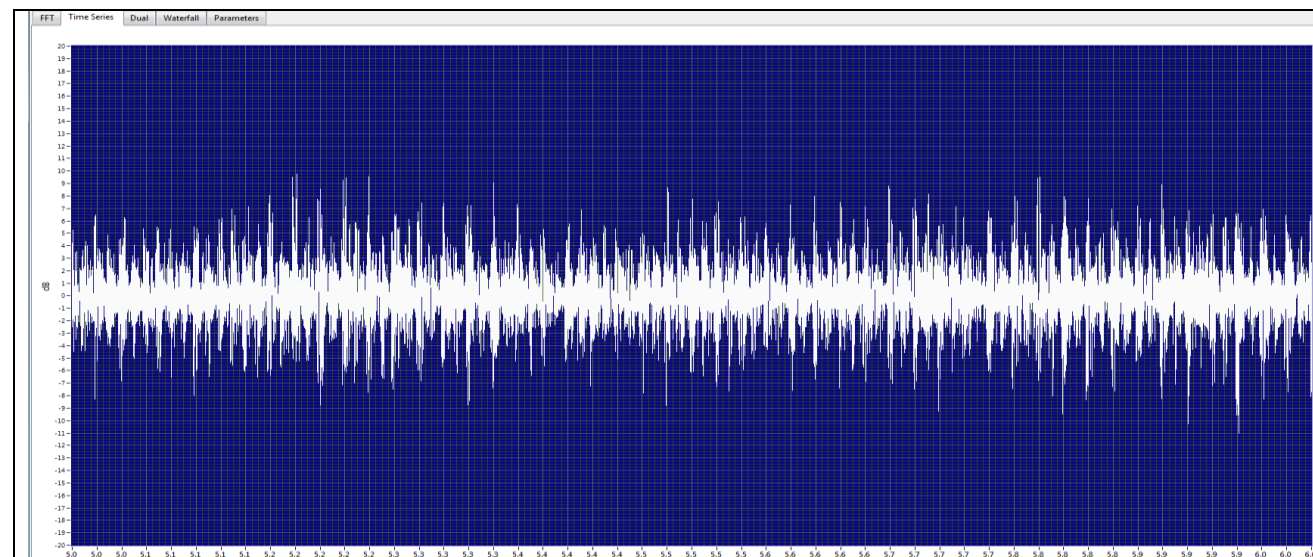
• Time Domain Analysis @ back panel of "UP-1046B"

Audio Analysis => **Abnormal ultrasound was detected at the back panel of circuit "UP-1046B"**

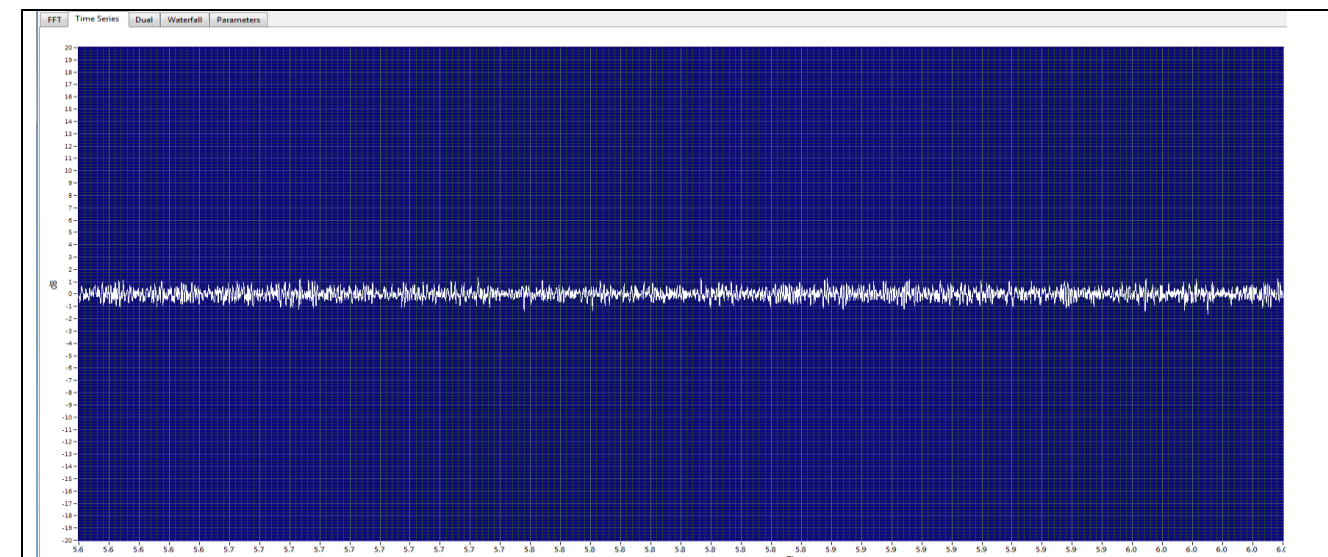
• Time Domain Analysis @ back panel of "UP-1046A"

• Audio Analysis => **No Abnormal ultrasound was detected.**
