Case history 6 using RTD embedded in the windings of the motor (con't)

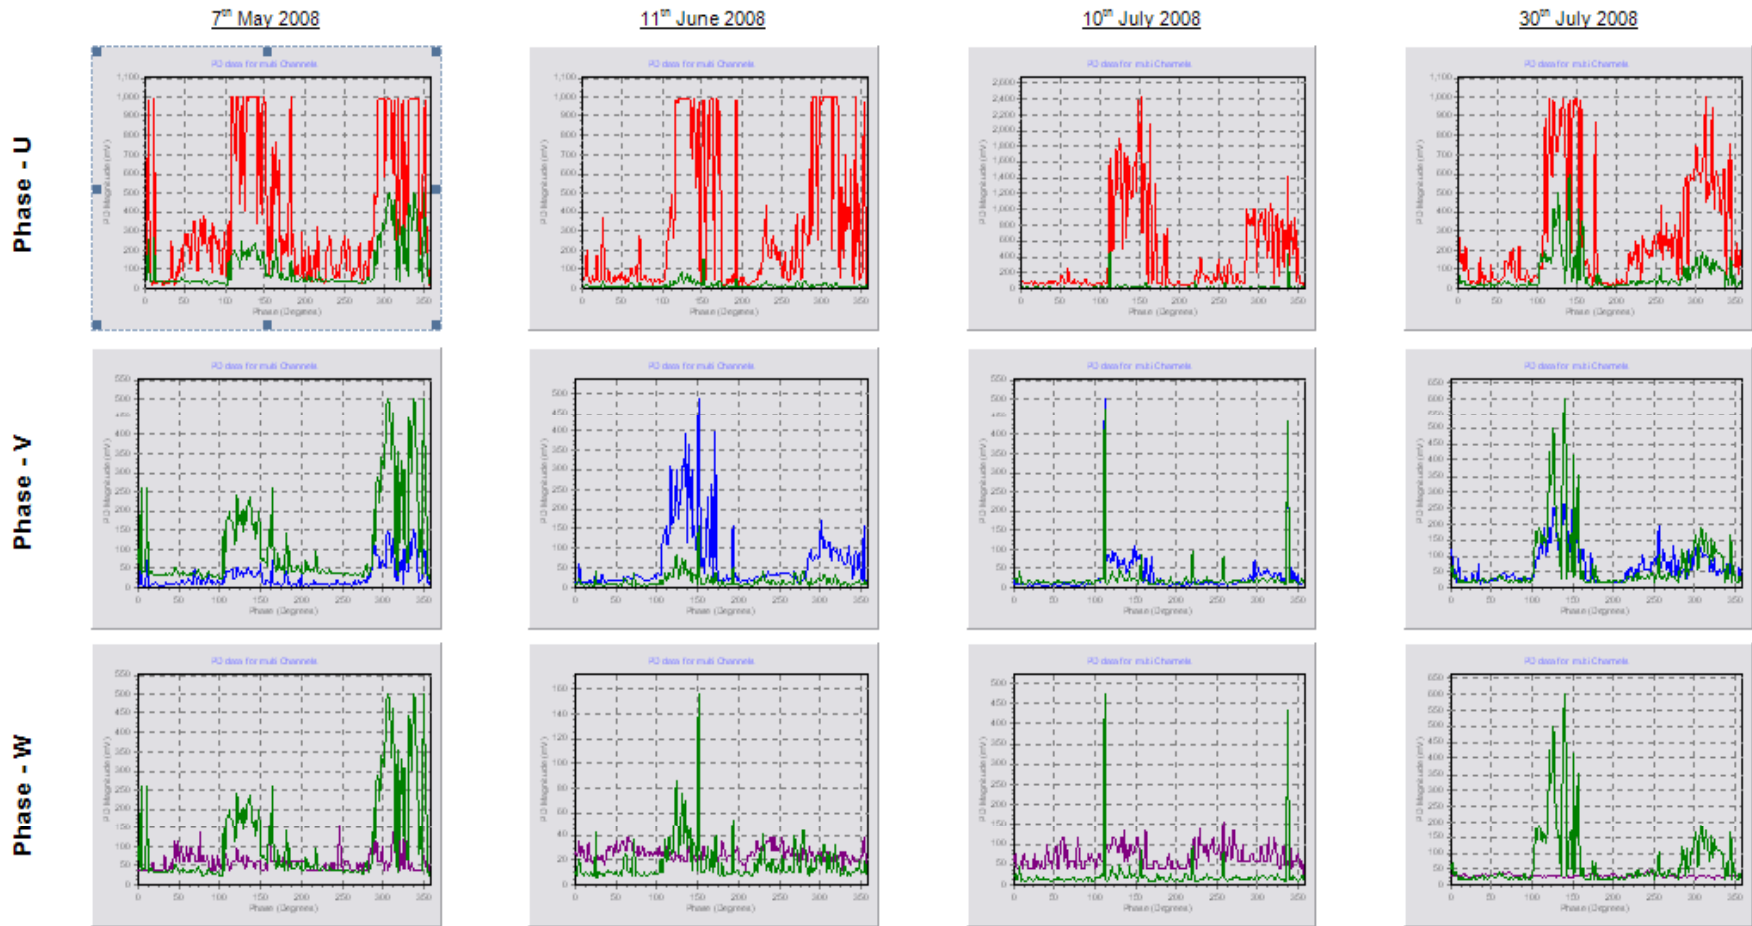
Phase	7 th May 2008	11 th June 2008	10 th July 2008	30 th July 2008
Ch1 – Phase U	Pd activity of 1004mV	Pd activity of 1004mV	Pd activity of 1600mV	Pd activity of 1000mV
Ch2 – Phase V	No Pd activity	Pd activity of 490mV	Pd activity of 100mV	No Pd activity
Ch3 – Phase W	No Pd activity	No Pd activity	No Pd activity	No Pd activity

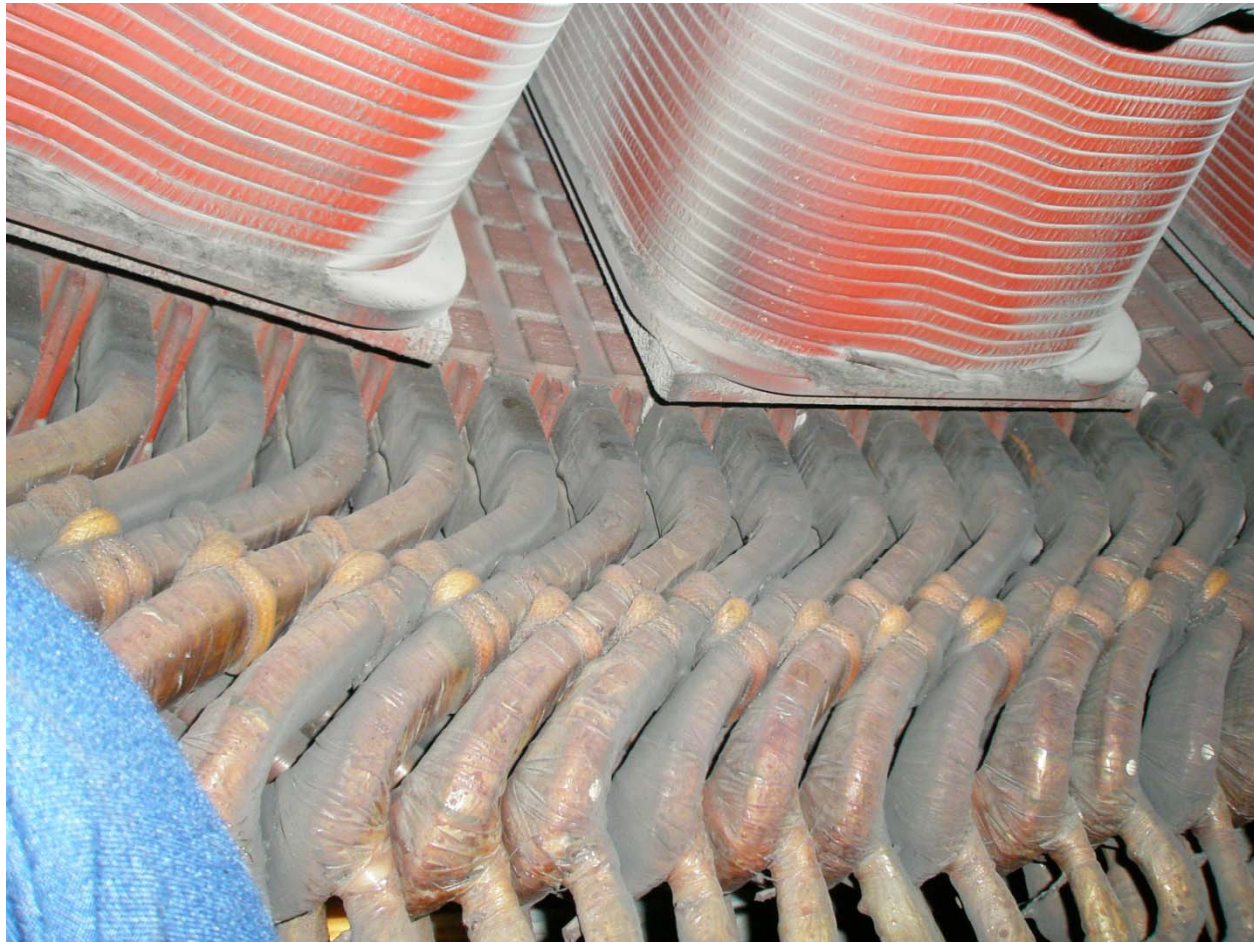
Glass tapes were found exposed on a few locations just outside the slot area due to peeling of corona tape.
