## Case History – 7 : Using Online Snapshot Ultrasonic Method

Equipment Under measurement : 22kV AIS ABB Switchgear

Date of Measurement : 17<sup>th</sup> March 2014

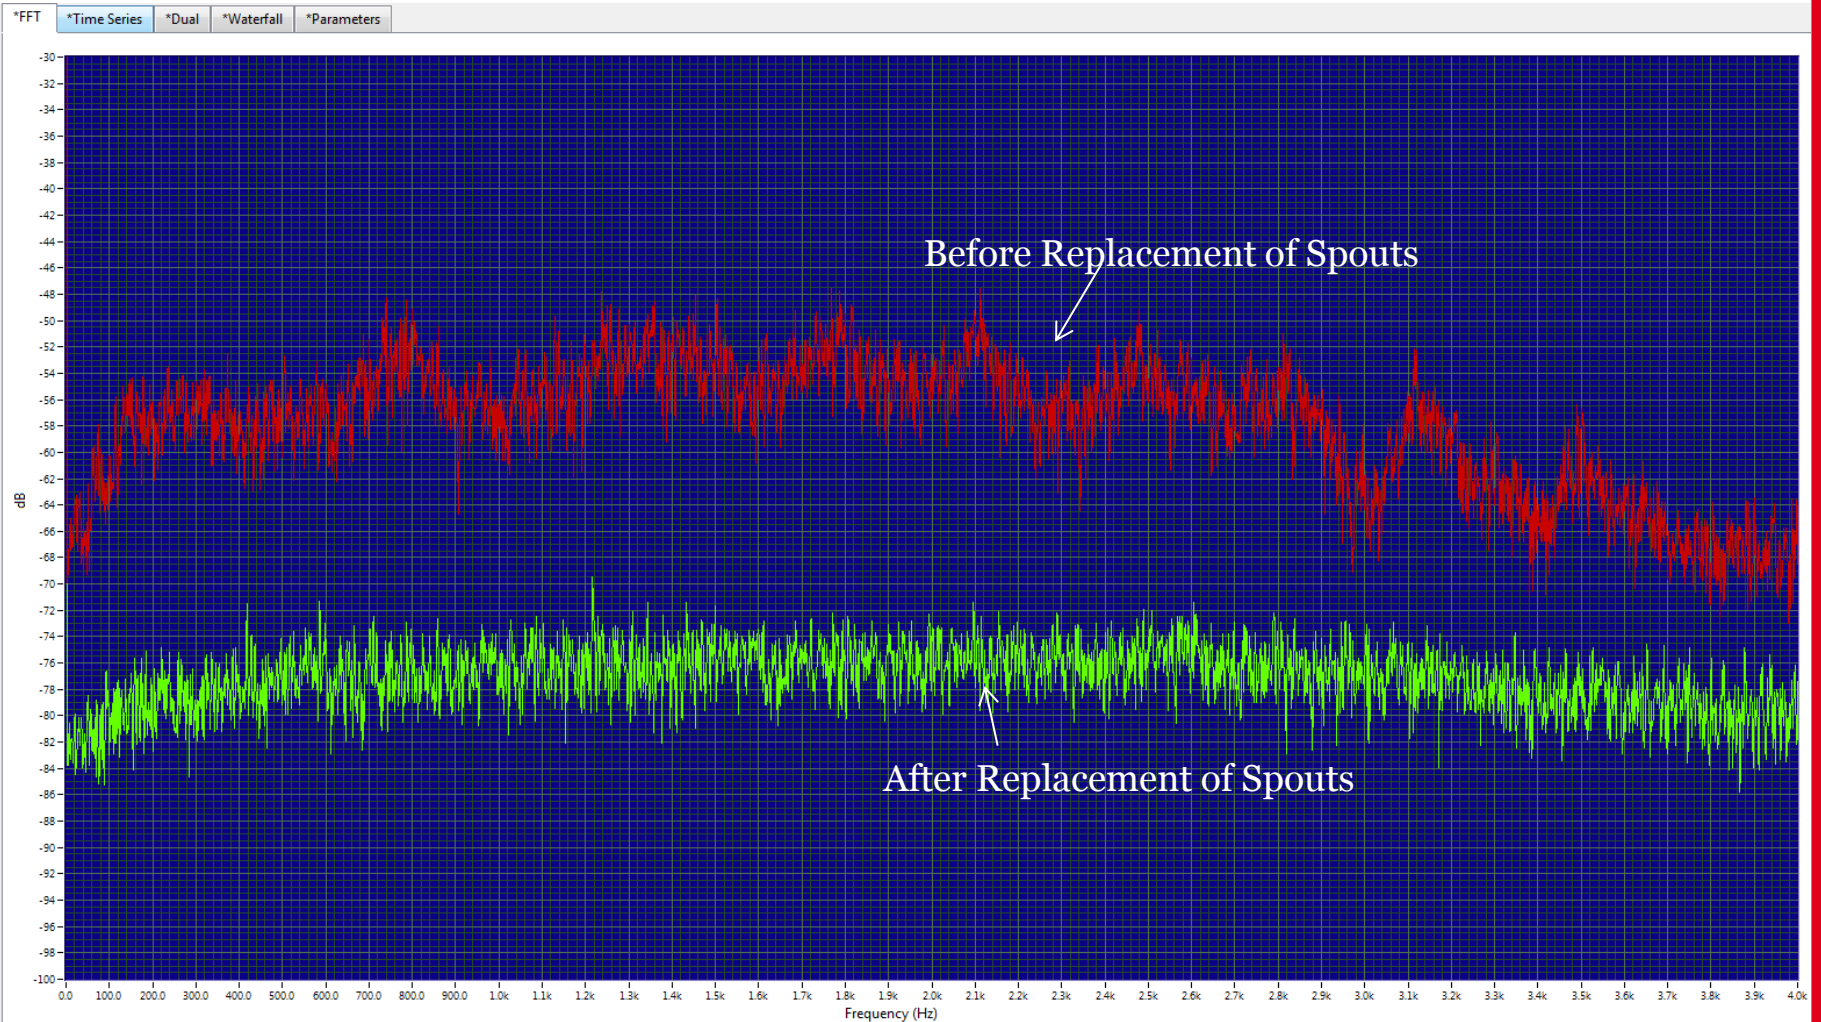
## 22kV AIS ABB SWITCHGEAR (BACK SIDE OF PG-2 PANEL)

- Frequency Domain

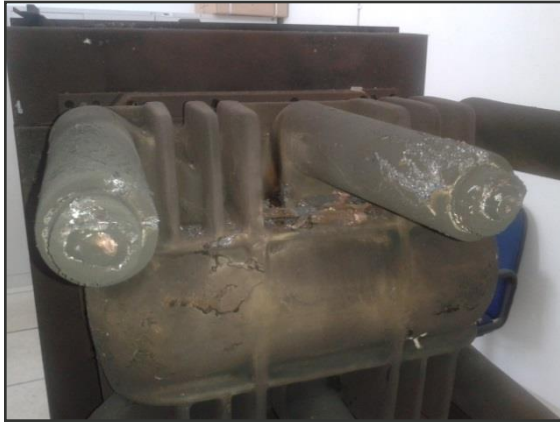
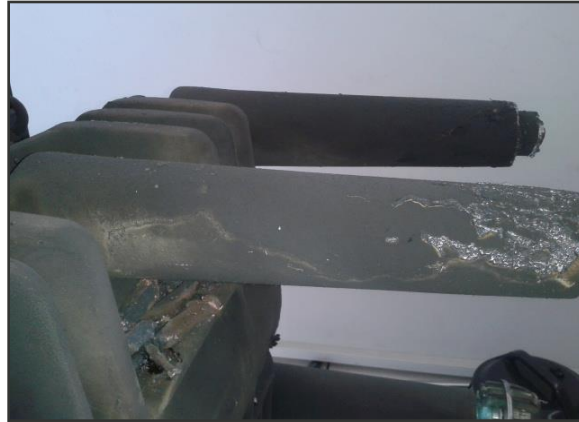
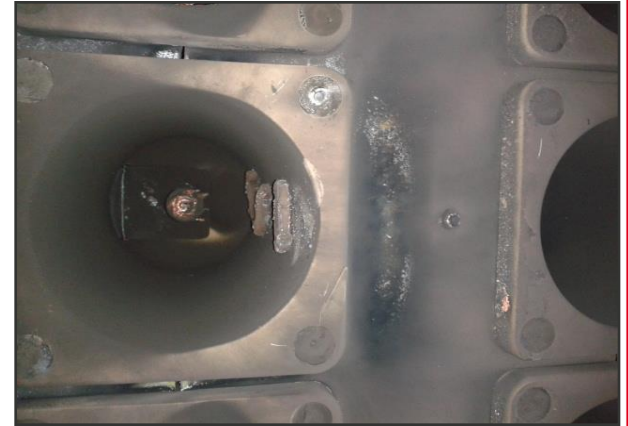
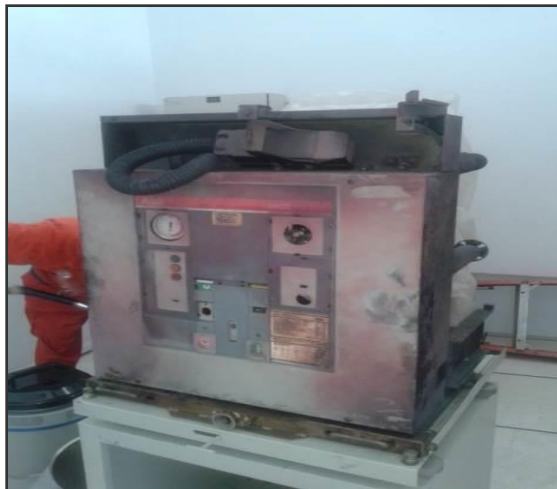
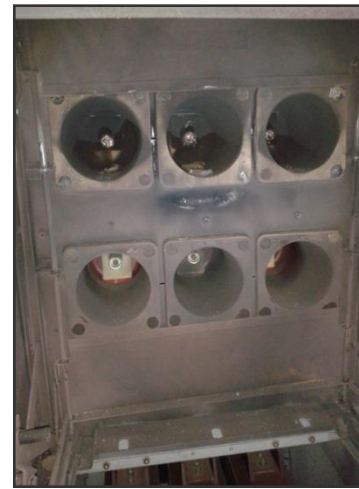
## Melted Contacts of 22kV Circuit Breaker
