Case History – 8 : Using Online Snapshot Ultrasonic Method

Equipment Under measurement : 22kV GIS Areva Switchgear

Date of Measurement : 19th May 2014

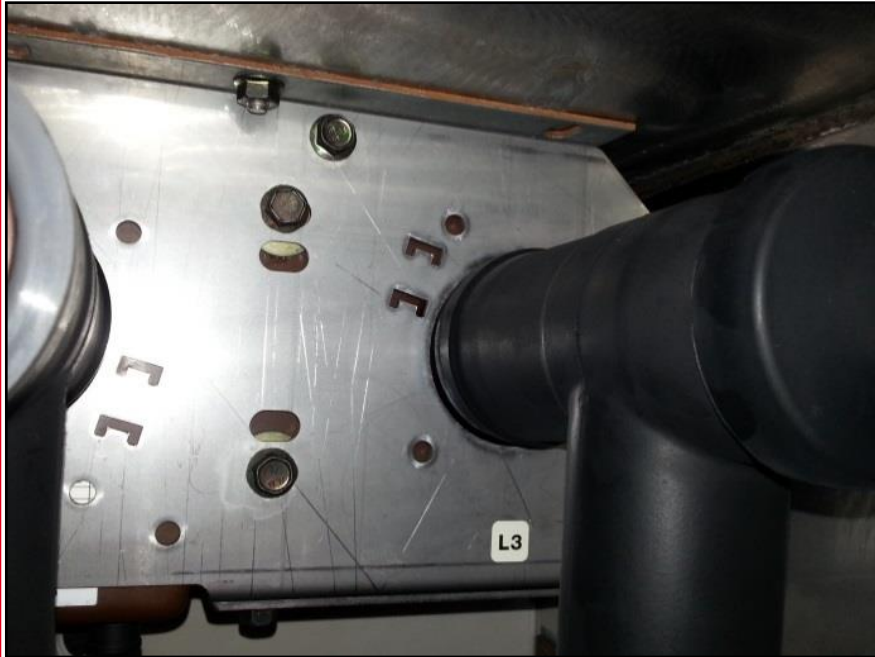
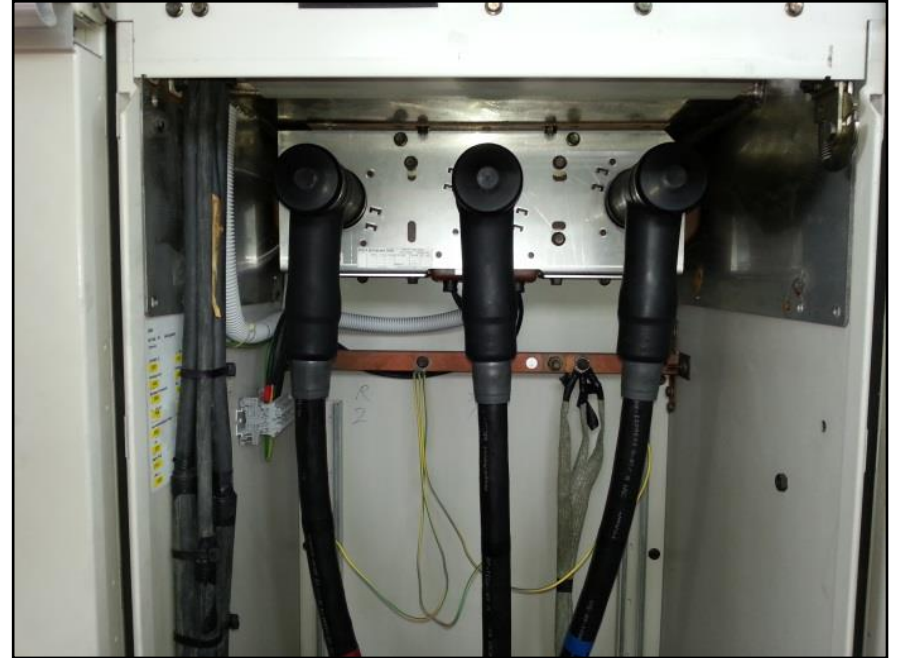
Loose 22kV Cable Termination Connection at Yellow Phase
