Case History – 22 : Using Online Acoustic Sensor Method

Equipment Under measurement : **22kV GIS AREVA Switchgear**

Date of Measurement : **14th November 2016**

Case History – 22 : Using Online Capacitive UHF Sensor Method

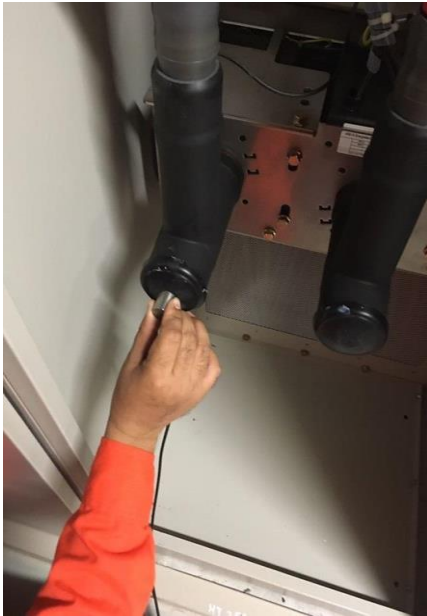
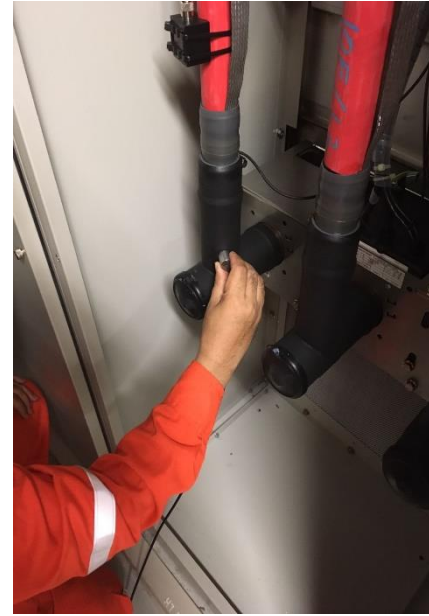
Sensor Used: **Acousitc sensor**

Observation: **Discharge at the Cable Termination of the Blue Phase.**

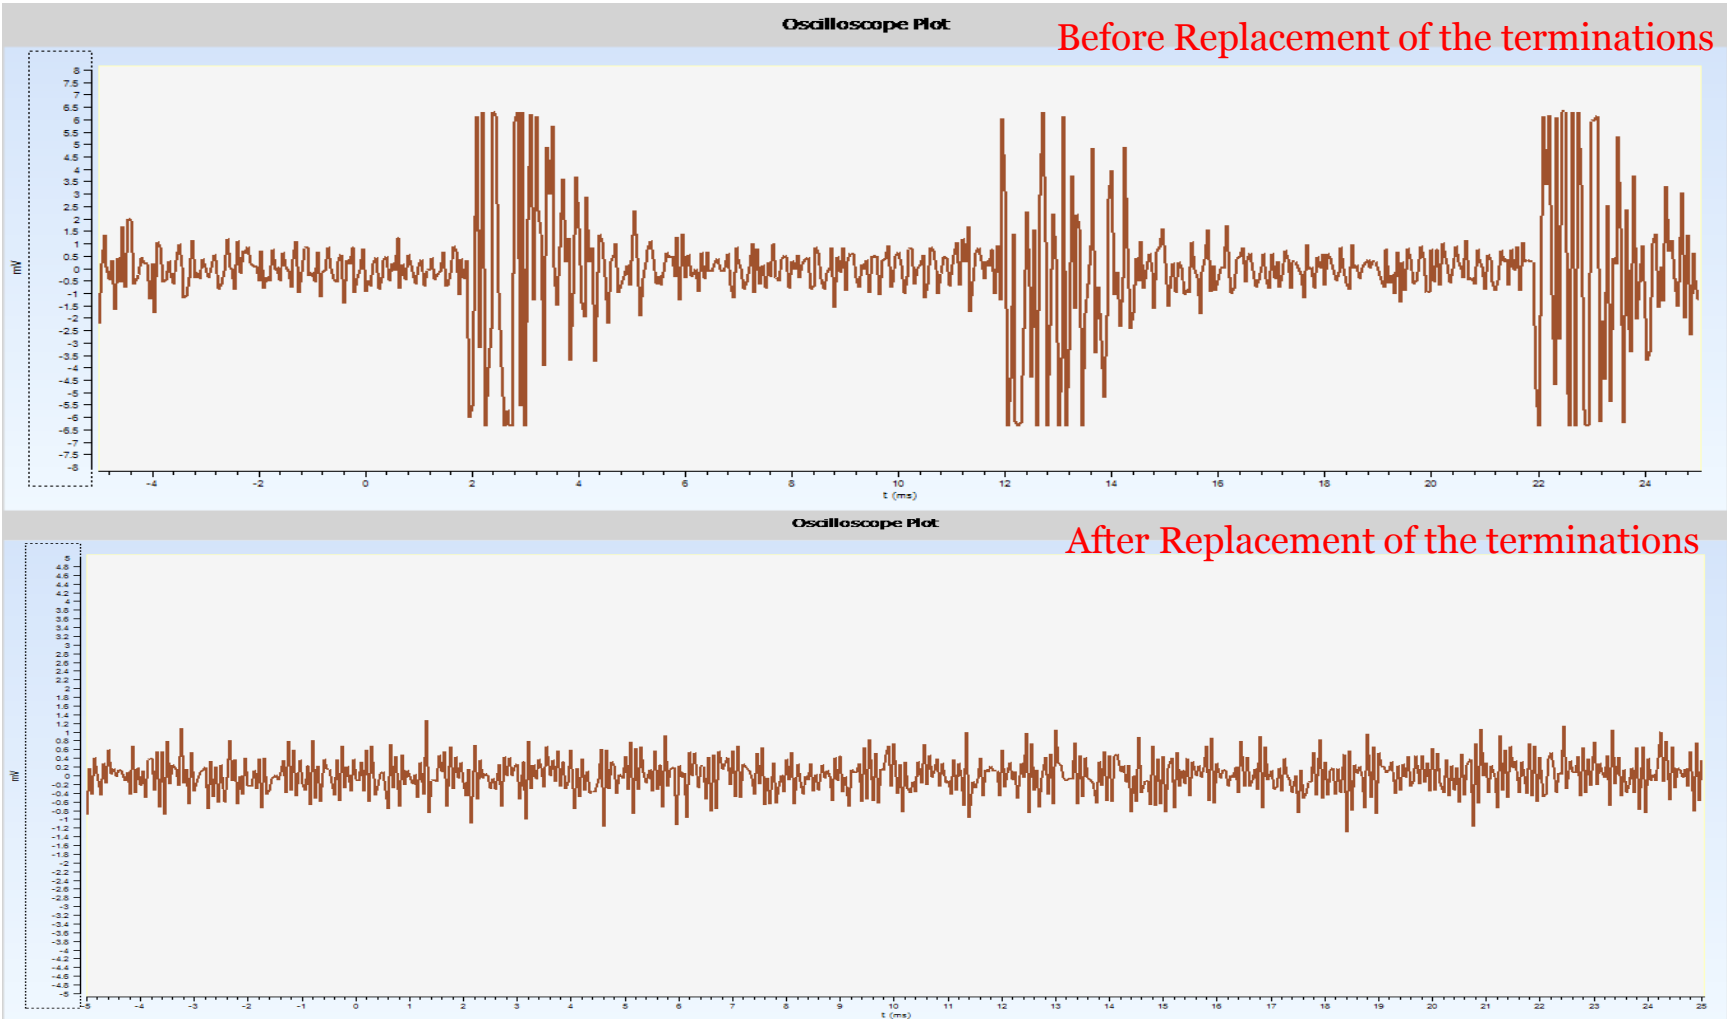
22kV GIS AREVA SWITCHGEAR, HT 251 (PHASE L3)

- Time Domain Plot

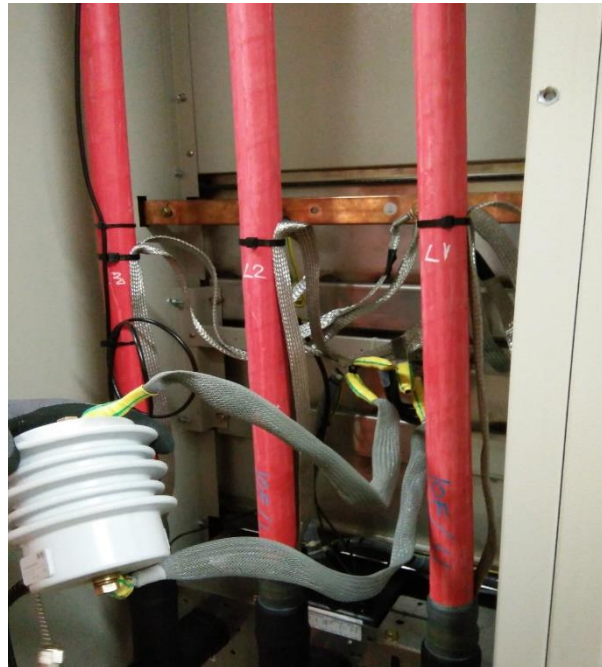
Connection Diagram

Sensor Used: **Capacitive UHF Sensor**

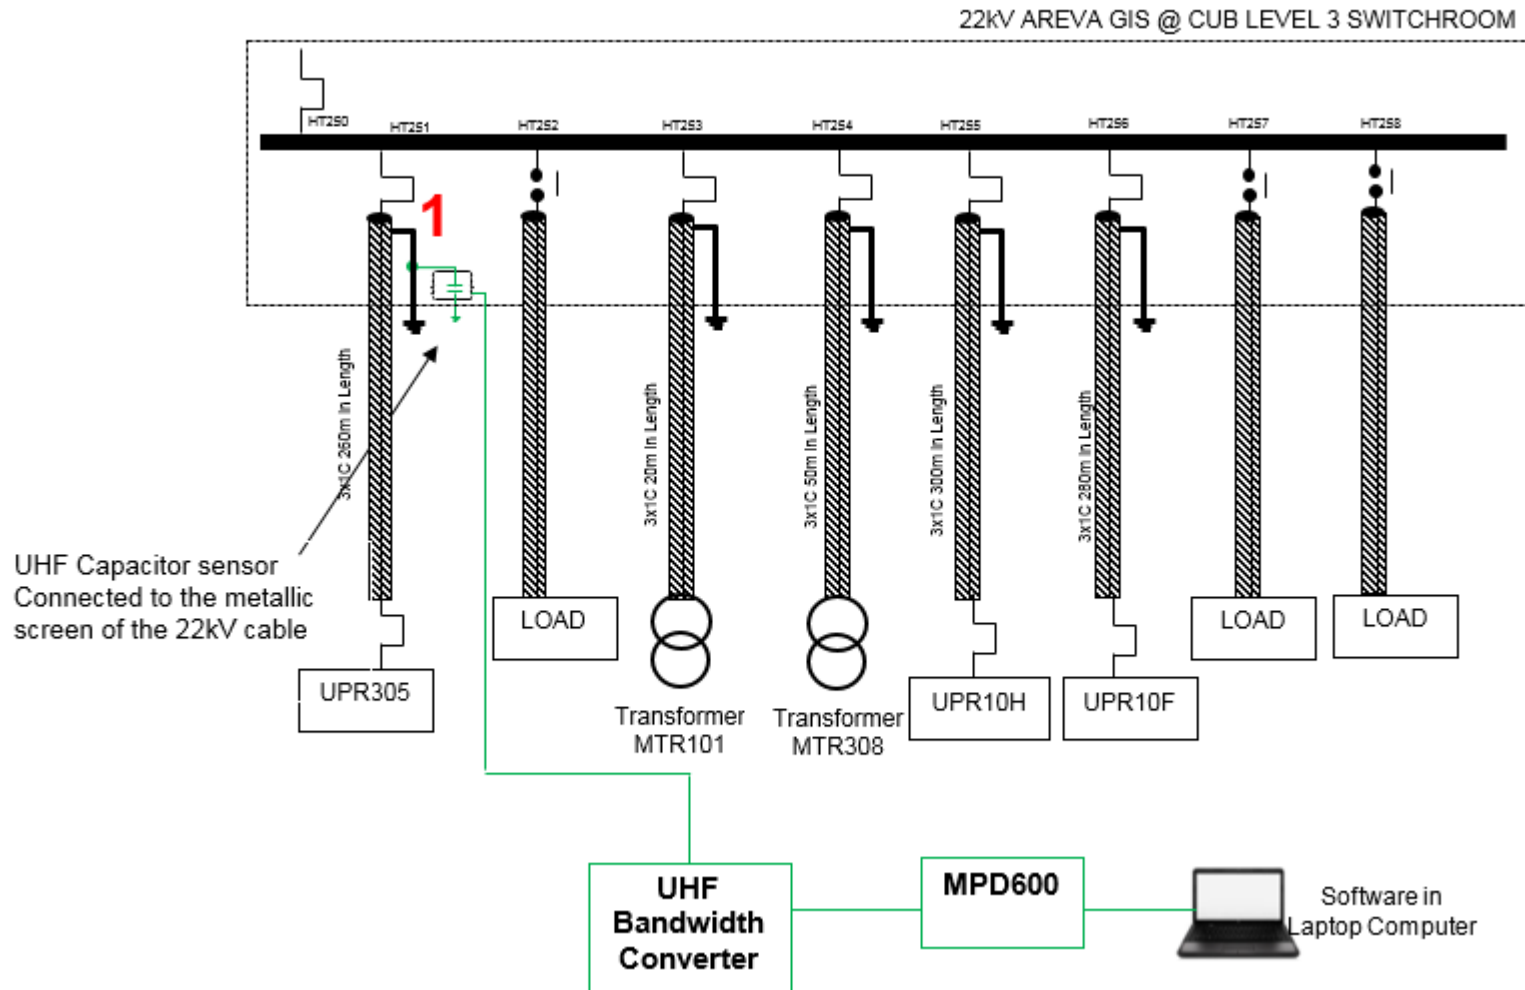
Observation: **Discharge at the Cable Termination of the Blue Phase.**

22kV GIS AREVA SWITCHGEAR, HT 251 (PHASE L3)

- Phase Resolved PD Plot

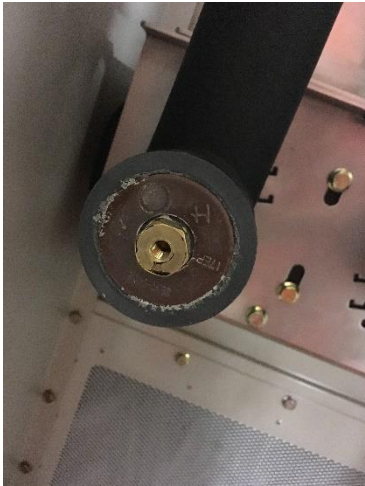
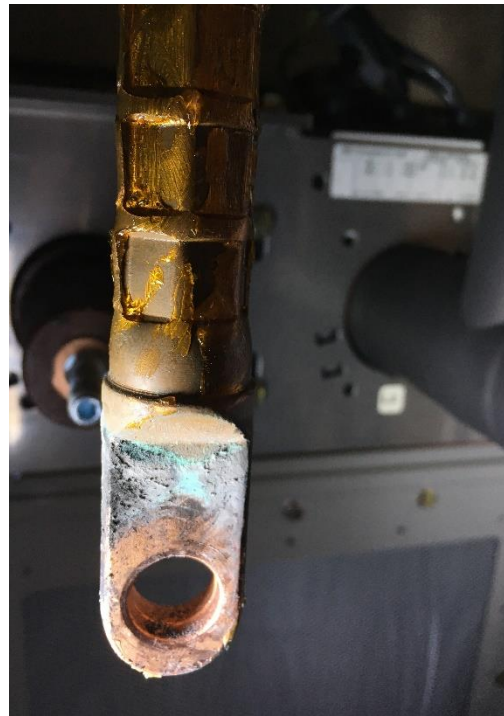
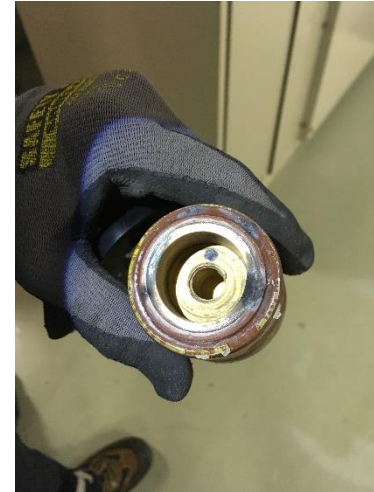
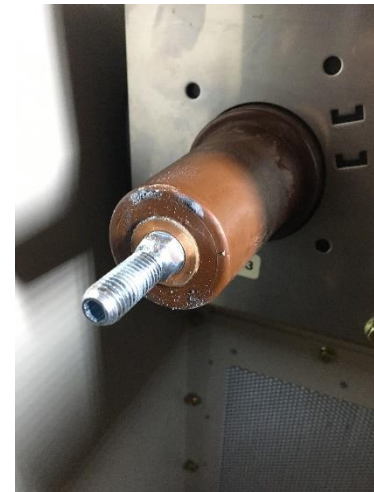
Burnt Marks found on the 22kV Cable Termination of phase L3
