Case History – 11 : Using Online Snapshot Ultrasonic Method

Equipment Under measurement : **22kV AIS Siemens Switchgear**

Date of Measurement : **08th August 2014**

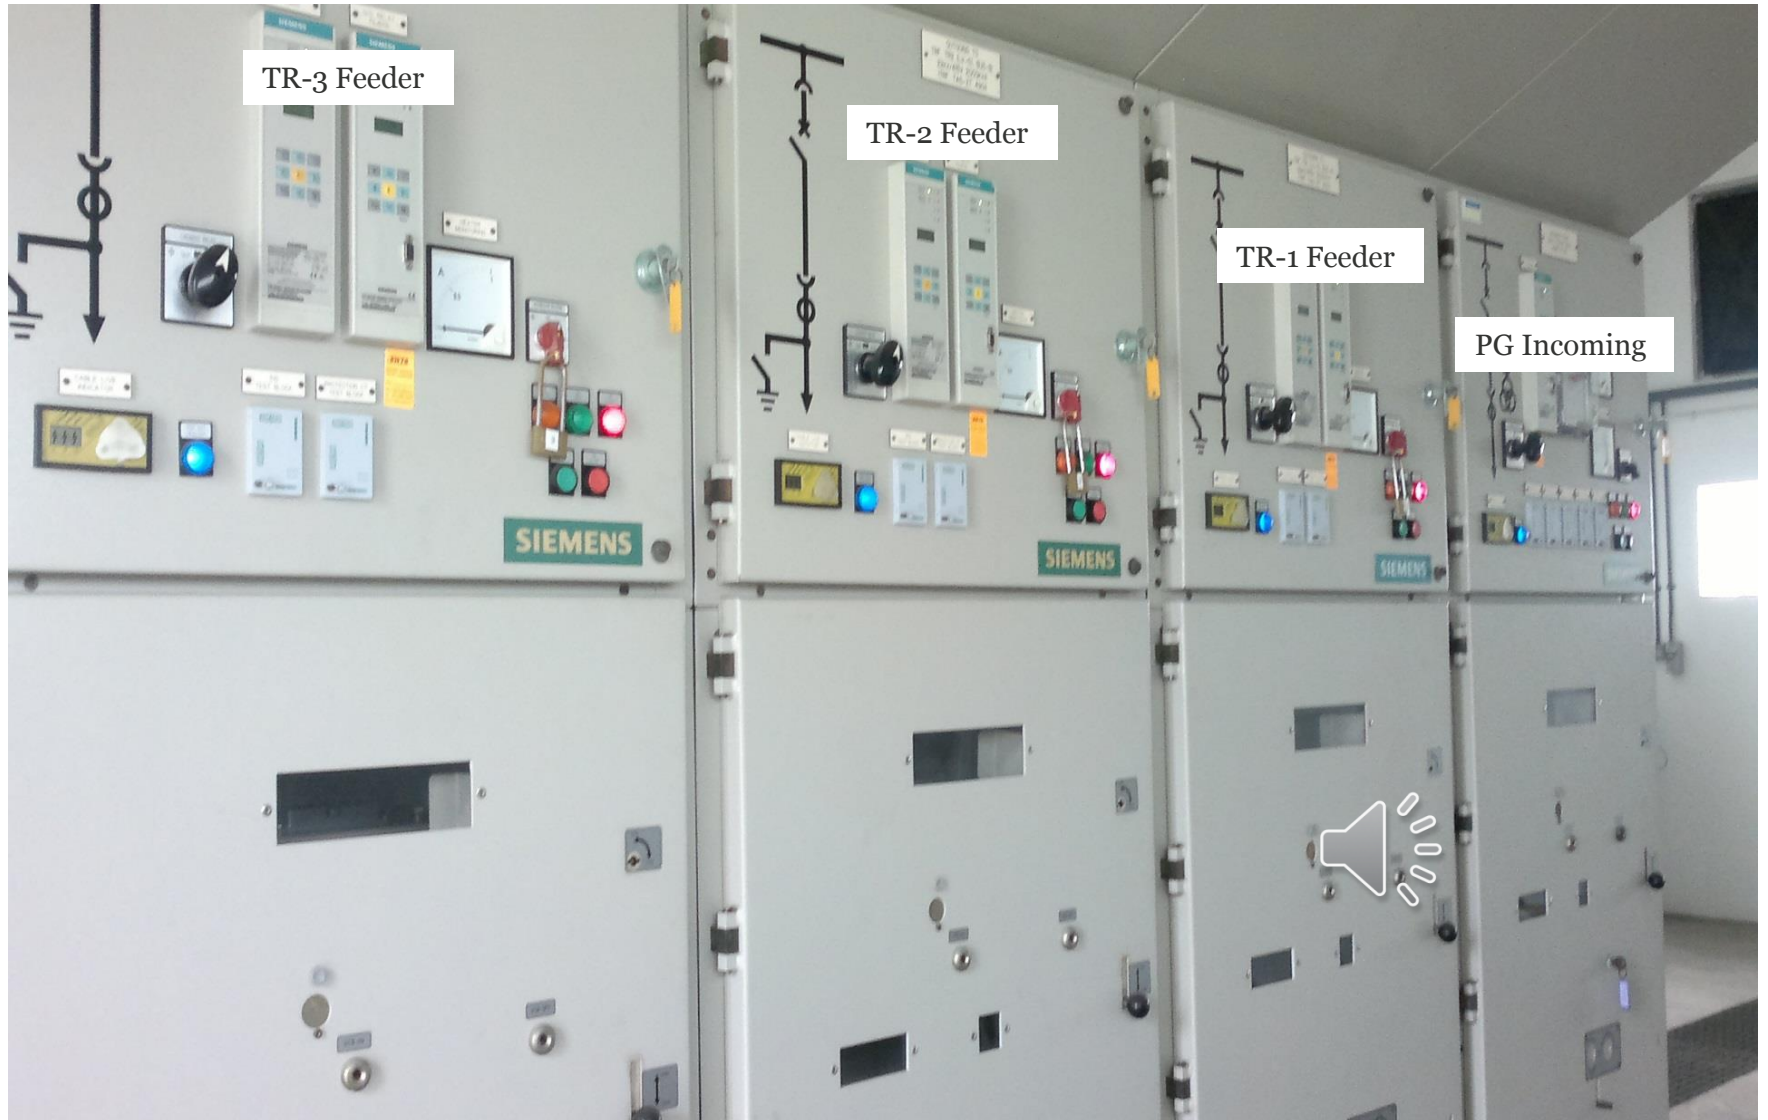
Observation: **Surface discharge was found at the Busbar and Circuit breaker contact with green corrosion spotted.**

Green Color at 22kV Circuit Breaker Contact, which indicate insufficient contact pressure
