## **Case History - 14: Using Online Ultrasonic Method**

Equipment Under Measurement: **22kV AIS, FUJI**

Date of Measurement: **15<sup>th</sup> July 2015**

**ONLINE PD MEASUREMENT USING SNAPSHOT ULTRASONIC SENSORS  
FOR 22kV FUJI AIS @ HT SWITCHROOM**

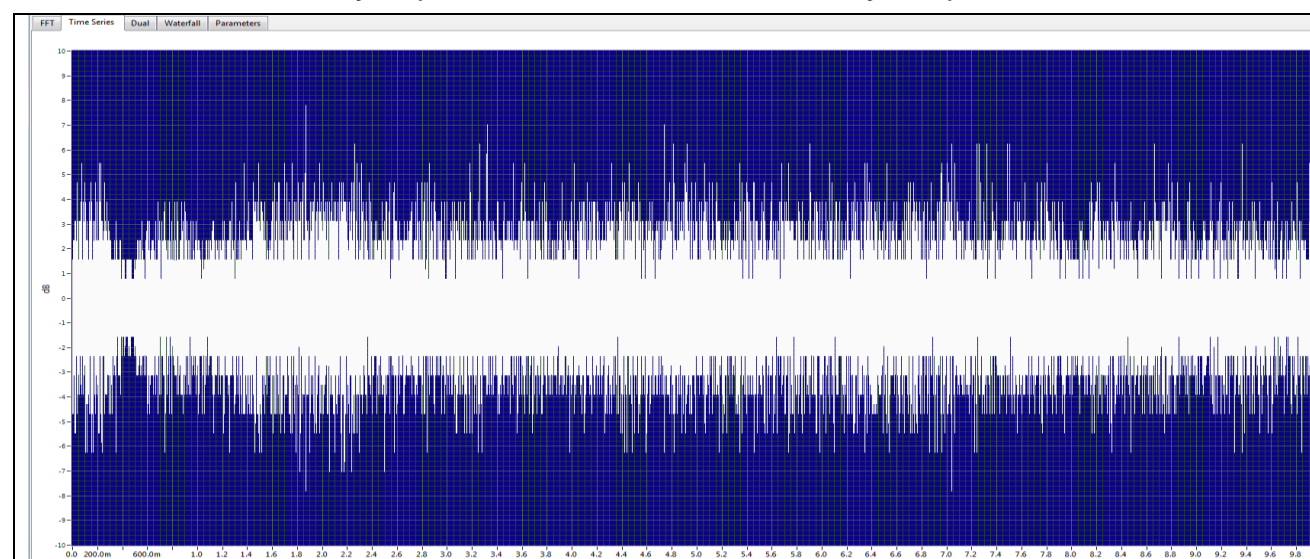
• **Time Domain Analysis (Before SDM \_ Measured on 15<sup>th</sup> July 2015)**

• Audio Analysis => **Abnormal ultrasound was detected.**

*\*SDM was done on 16<sup>th</sup> July 2015.*

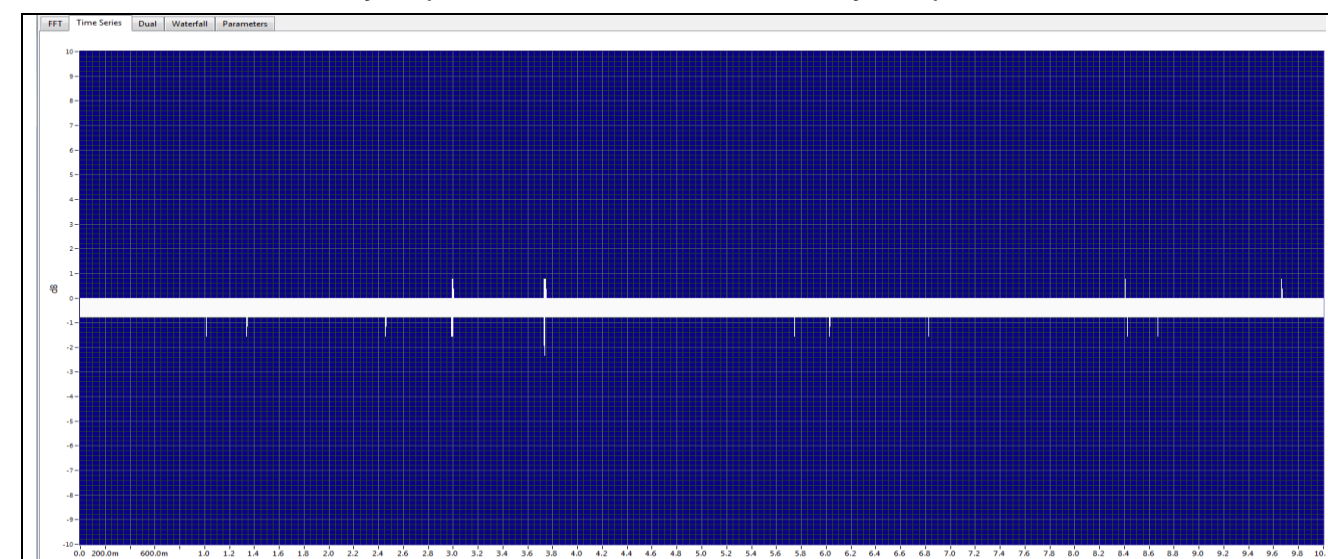
• **Time Domain Analysis (After SDM \_ Measured on 20<sup>th</sup> July 2015)**

• Audio Analysis => **No Abnormal ultrasound was detected**
