Case History - 27: Online PD measurement using Airborne Ultrasonic

Equipment under Measurement	: 22kV AIS Switchgear
Date of Measurement	: 04th September 2018
PD test Set	: Ultra TEV plus 2 (EA Technology)
Sensor Used	: Airborne Ultrasonic Sensor
Observation	: Surface Discharge (Burn Mark) was found on the VT of Incoming circuit.

ONLINE PD MEASUREMENT USING AIRBORNE ULTRASONIC SENSORS

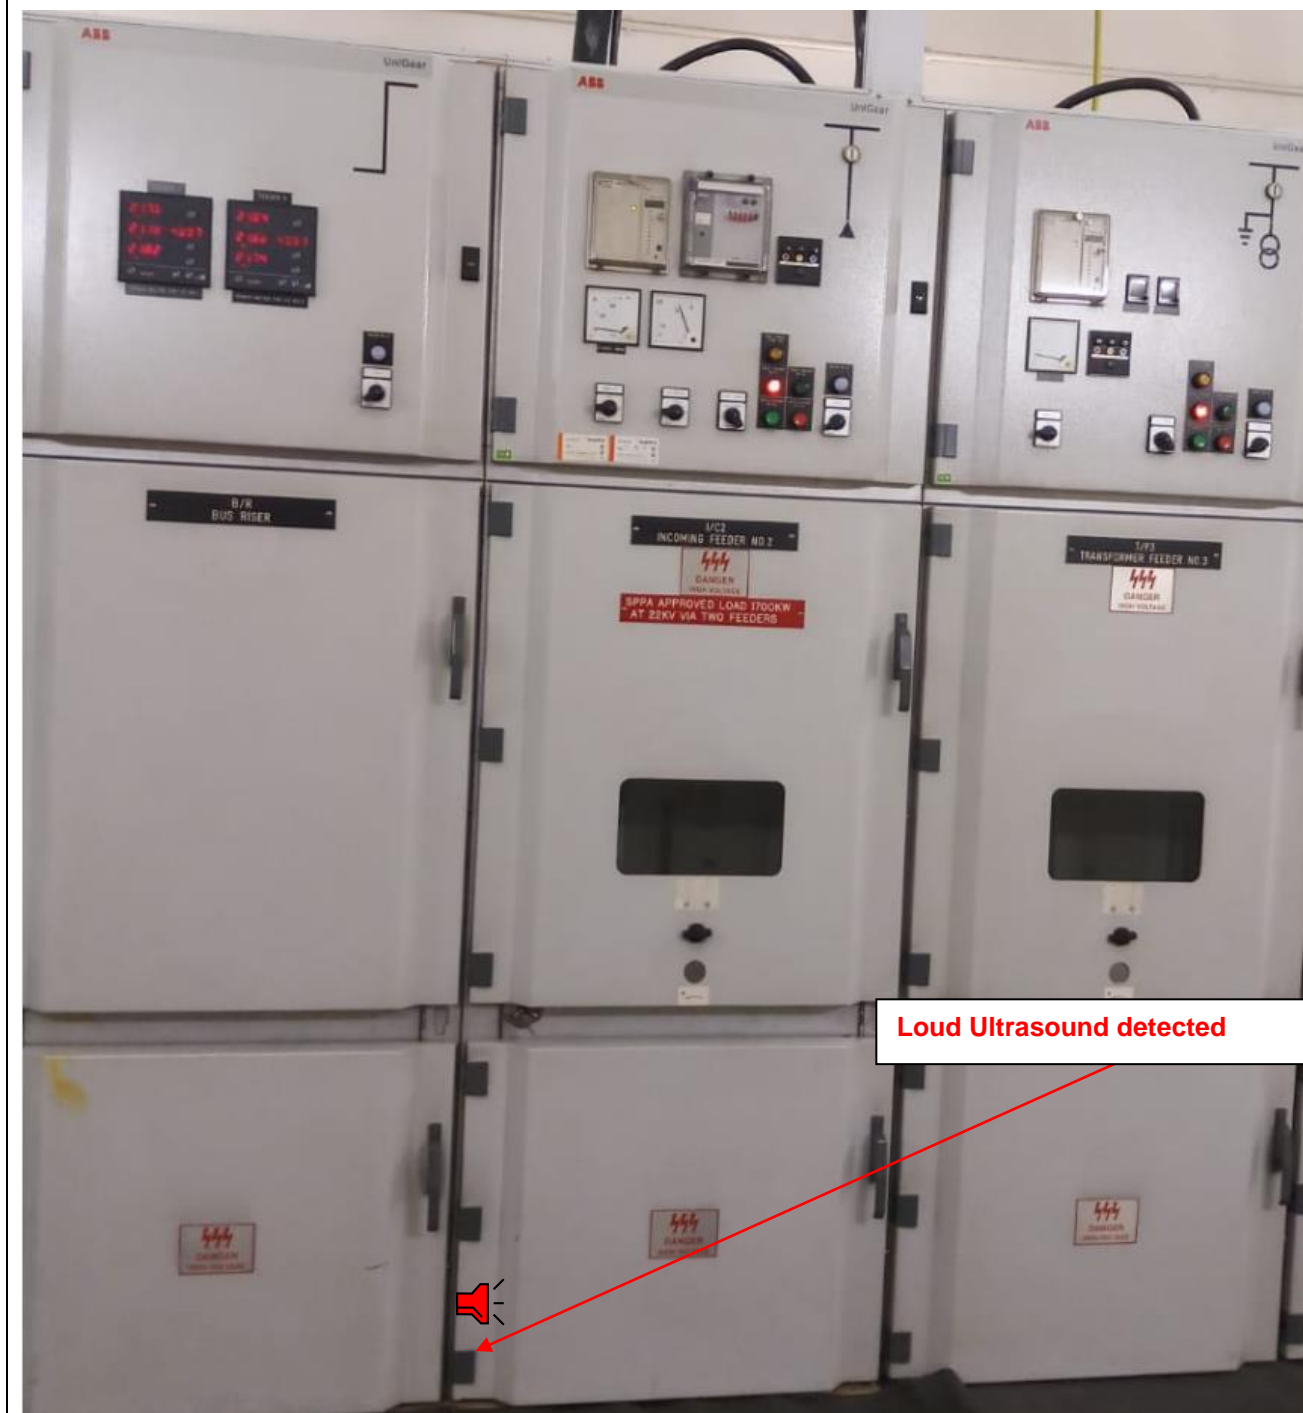
Phase Resolved Ultrasound on Front Panel of "Incoming Feeder No.2" (With VT) on 17th August 2018

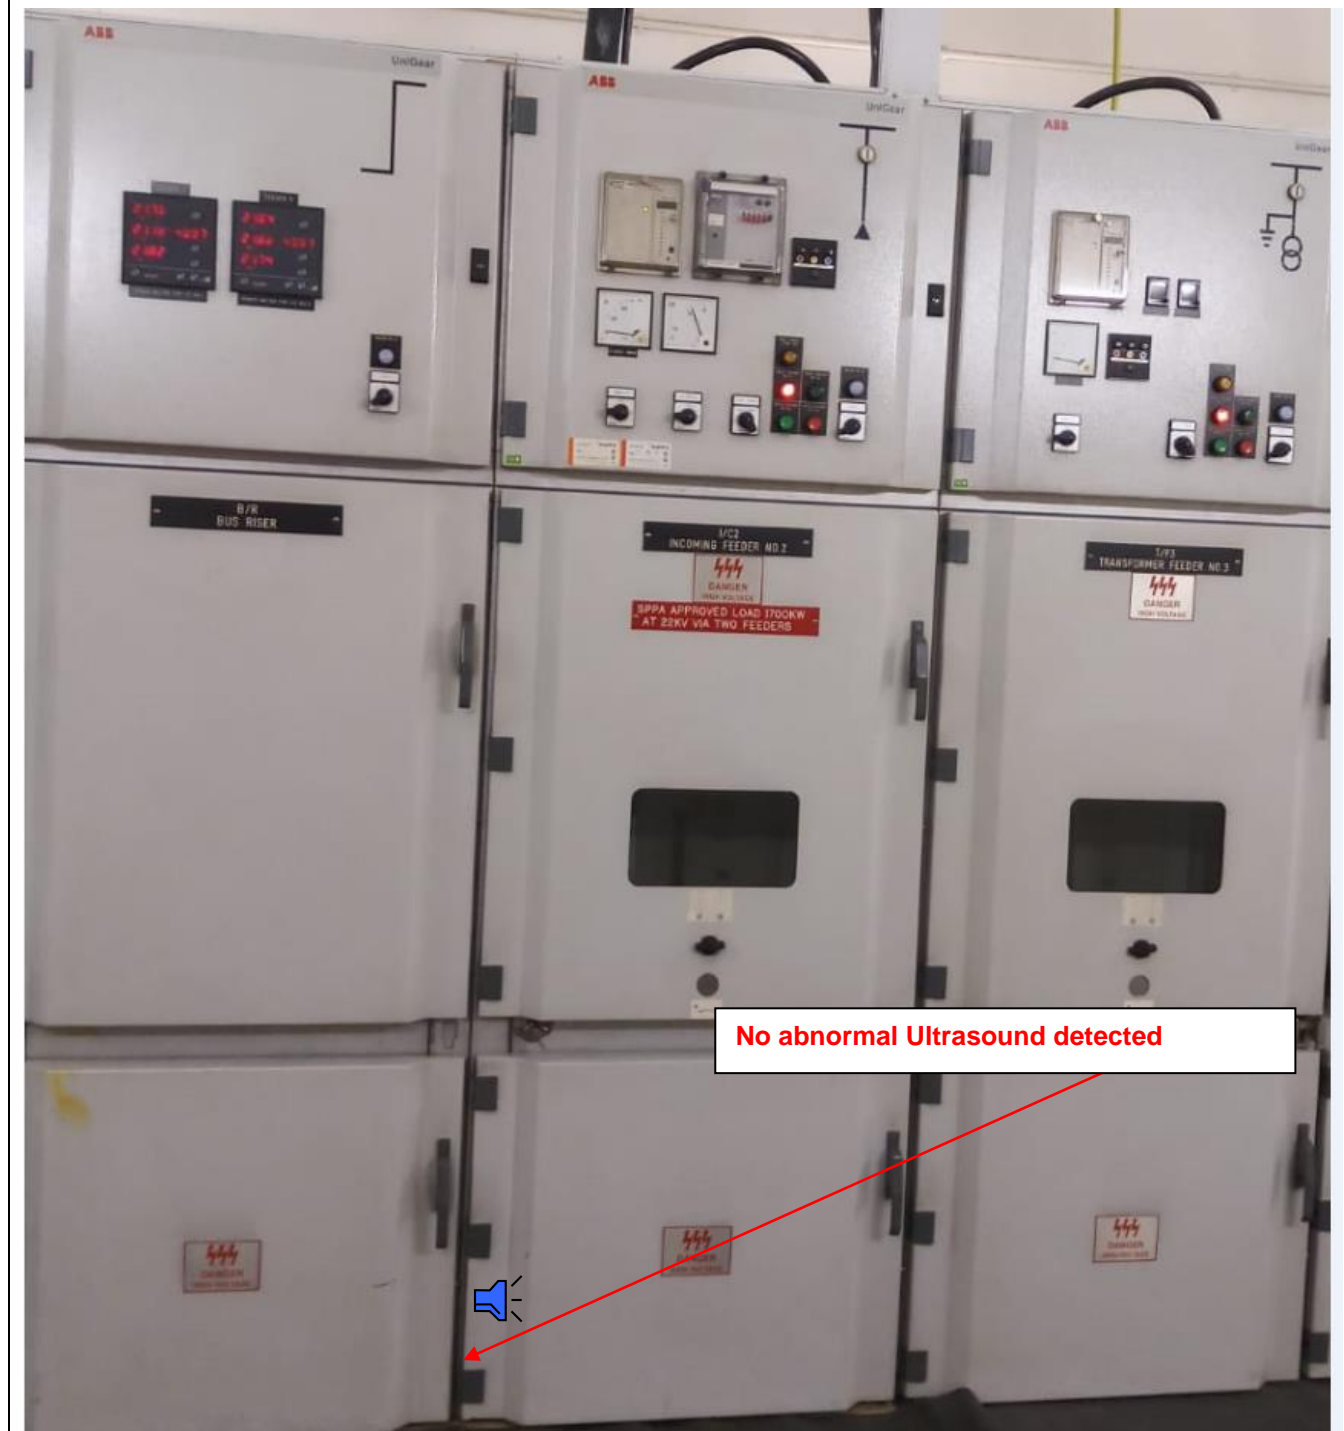
Phase Resolved Ultrasound Front Panel of "Incoming Feeder No.2" (Without VT) on 04th September 2018

Scheduled Shutdown on 22kV AIS was on 30th August 2018.

“Power Grid Incoming No.2” panel was investigated during the shutdown servicing.

Burn mark was found on the Voltage Transformer and VT was isolated.
